PRIVATE WATER SUPPLIES – CASE STUDY 2013/19

Water safety plan approach to improving the safety of a private supply

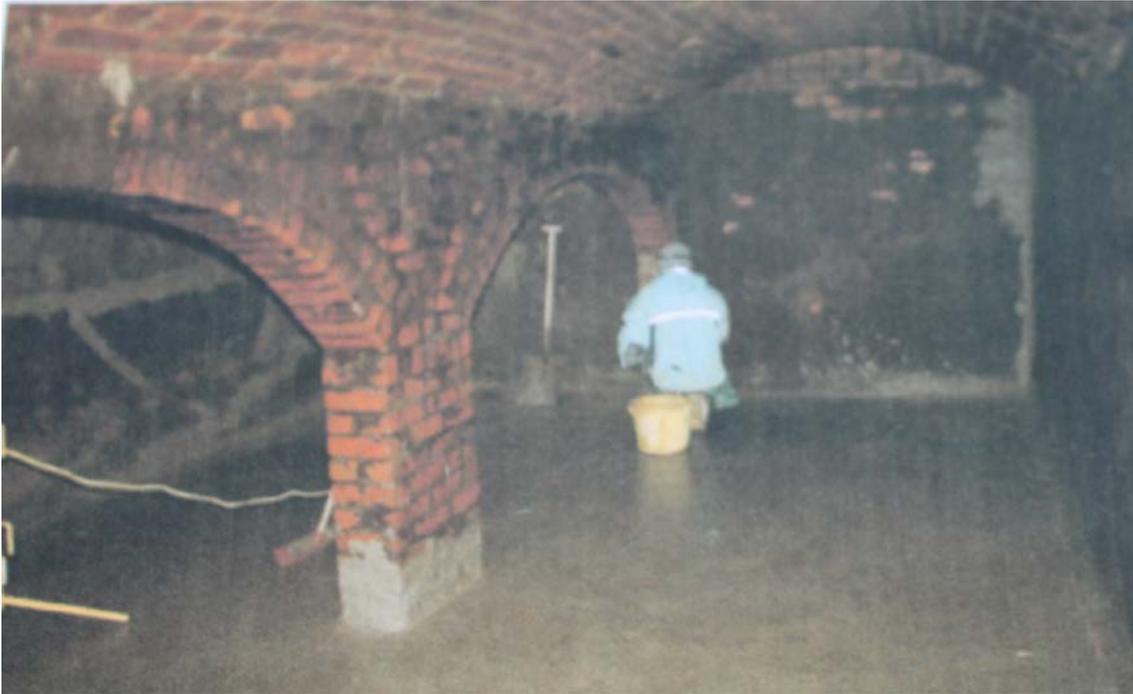
The owner found that only one spring was affected and immediately instigated his emergency plan. This comprised diverting the spring to waste (through the overflow) and blocking off the pipework to the reservoir to prevent any more contaminated water entering the supply. However, the water in the reservoir was already contaminated. The local authority attended the site and endorsed the owner's alternative supply arrangement. It was felt that the spring that was unaffected could still be used if the reservoir was bypassed. The reservoir was isolated and flow from the uncontaminated spring (chamber) diverted into a temporary reservoir (two water tanks). The tanks were then connected to existing downstream pipework to the properties. This allowed the reservoir to be drained to waste.

Figure 24: Cleaning inside the vaulted brick reservoir

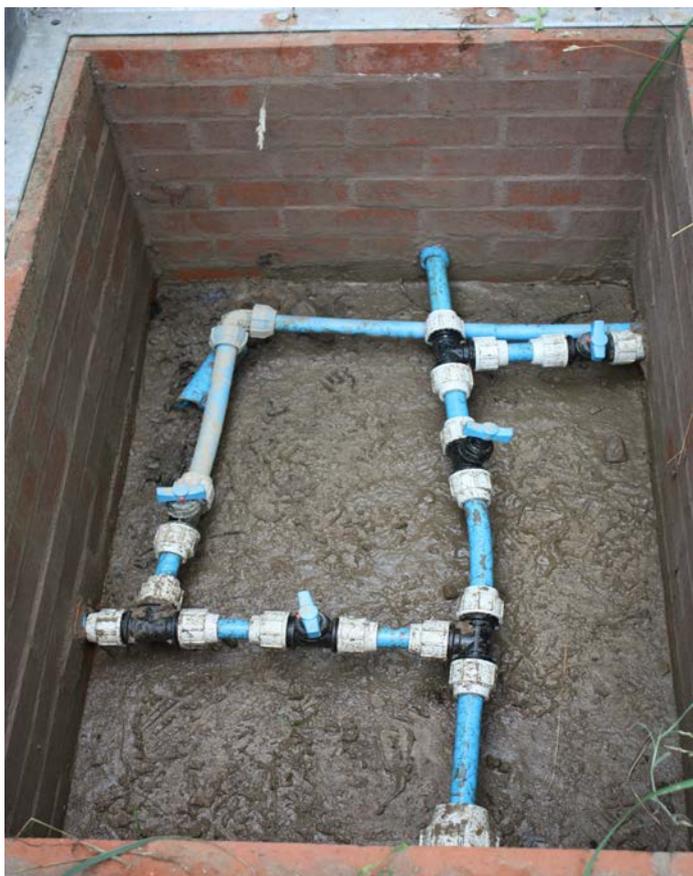
Figure 25: Valve chamber

The owner engaged a specialist water contractor to uprate the treatment system so that it was capable of dealing with the raw water quality challenges of high colour and turbidity due to natural organic matter. A sand filter was installed as additional pre-treatment and the owner arranged for annual inspections thereafter. The reservoir was cleaned out by jet spray and then disinfected and flushed, likewise the downstream pipework. While these works were taking place, the owner checked the location and condition of the existing pipework and replaced a section in poor condition. A bypass valve was installed after each spring chamber to facilitate running to waste, enabling timely and effective action in any future event and to improve resilience generally (enabling each source to be operated independently of the other).
