PRIVATE WATER SUPPLIES – CASE STUDY 2014/01

Verifying that improvement have been made to a village supply

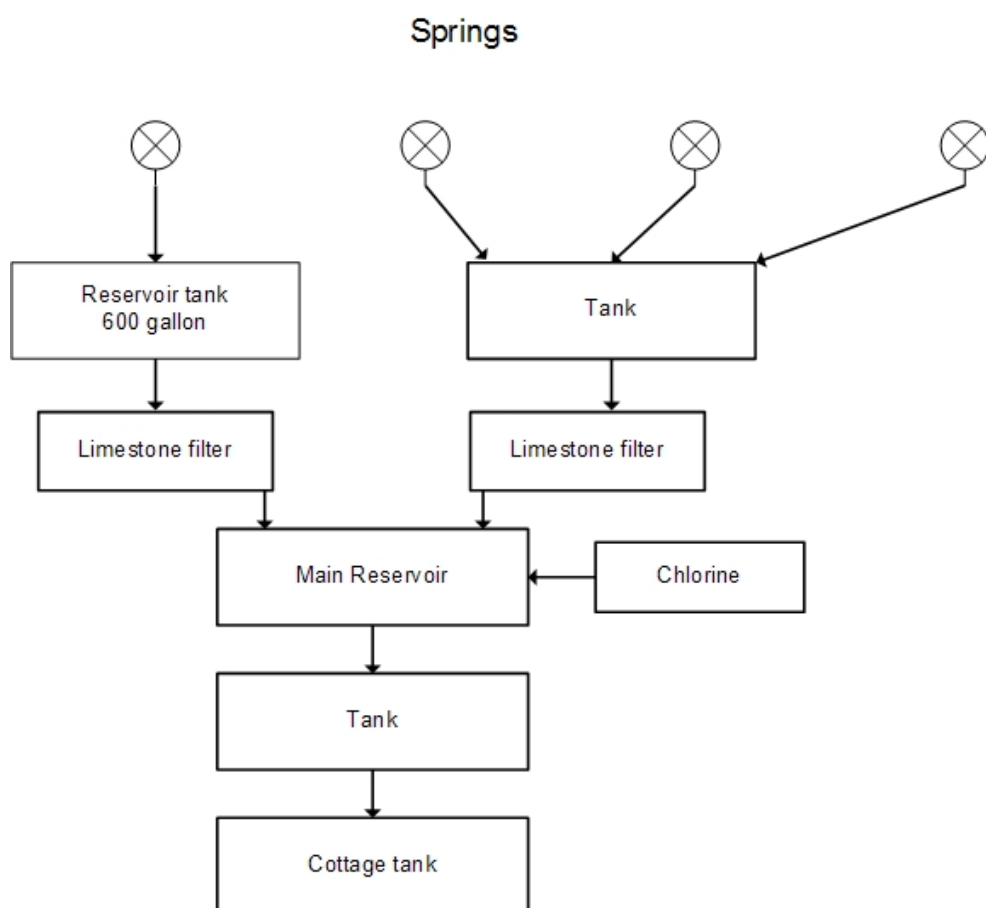
Figure 13: Diagram of water supply

This case study relates to a Regulation 9 spring supply feeding a village with a resident population of 200 and a temporary population of 499 attending private parties. The source comprises a number of springs and collection chambers which range in construction and condition. Most of the collection feed into a main reservoir via a brick built chamber and a raised limestone filter bed.

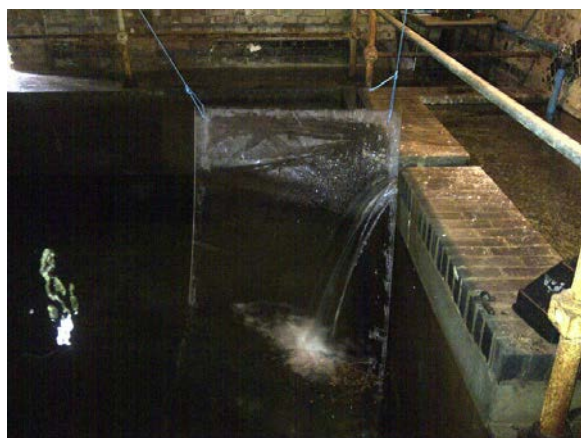
Figure 14a: Rudimentary arrangement for chlorine mixing (perspex sheet)

Figure 14a shows rudimentary attempts to improve mixing of the chlorine in the reservoir via a perspex sheet hung in the flow of the chlorinated water as the point where it enters the contact tank via a weir. The improved monitoring and instrumentation can be seen in Figure 14b.

Although the system has been improved, further advice was able to be given regarding the chemical mixing, location of instrumentation and contact tank mixing arrangements.

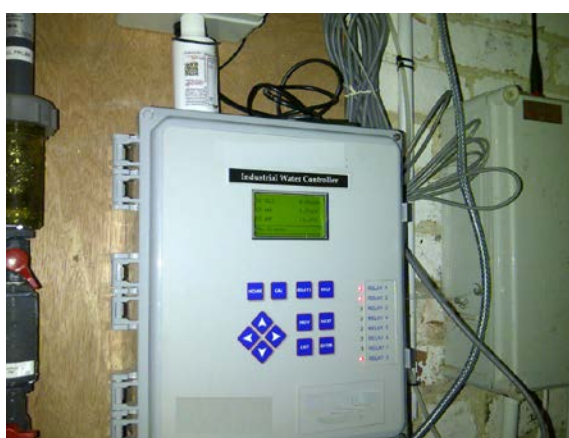
Figure 14b: Improved chlorine measurement and monitoring

Together with the local authority, the Inspectorate visited the supply in August 2014 to assess the work undertaken to comply with the Notice. The chlorine dosing system was found to be working correctly, and pH correction was now being undertaken via an automatically controlled dosing system.

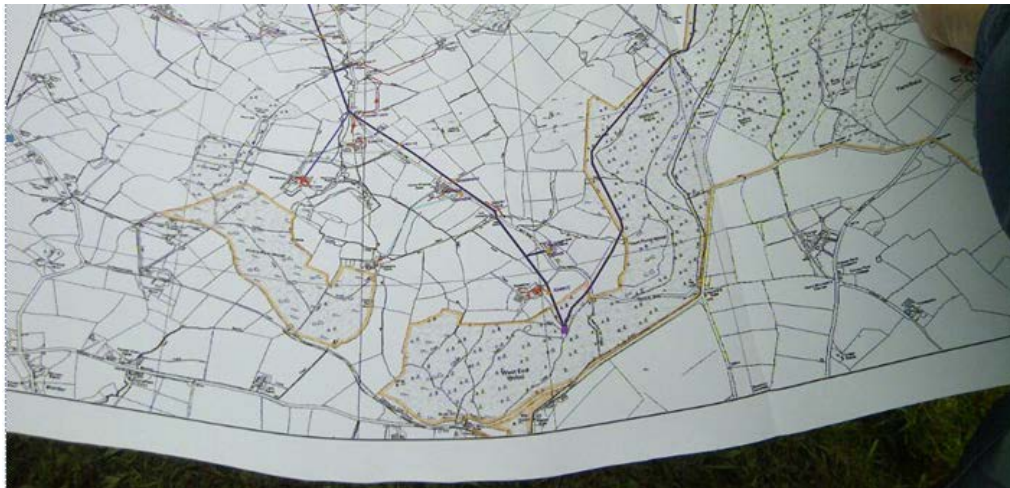
Figure 15: Plan of the supply system

The supply owners produced a detailed plan of the distribution system (Figure 15) and a log book to demonstrate that they were taking on-site chlorine readings at a range of representative points to verify that the residual disinfectant was persisting to the end of the network. The distribution map really supported the Inspectorate's confidence in the ongoing management of this supply – showing details of where the underground pipework was located for any potential repair and maintenance work, together with the diameter of the pipes throughout the network. For many private water supplies, maps of the assets are not available. Where this is the case it will show as

a very high risk when captured in the risk assessment tool. Underground assets are not straightforward to locate, but opportunities should not be lost to capture information to put together a picture of the supply system over time. For example, when any mains repair takes place, a record should be made about where it was located, the size and material of the pipe, and its condition. In addition, the location of valves and hydrants are good clues as to the location and probable orientation of pipework.
