PRIVATE WATER SUPPLIES - CASE STUDY 2012/9

Improving the safety and sustainability of a failing rural community water supply in a cost effective manner

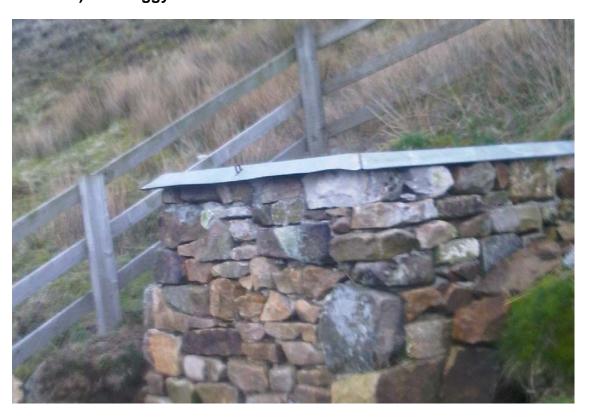
Figure 12: Spring chamber located on a steep slope, surrounded by fencing (0.5 m from the chamber) and boggy land and swallow holes

After liaising with the local authority, the Inspectorate and the local water company undertook a joint site visit. This revealed that while the spring chamber was protected by a post and rail fence, this was sited very close to the chamber (0.5m). There was evidence of sheep droppings on the slope immediately above, and the boggy ground and swallow holes surrounding the spring chamber indicated a route of ingress to the supply of faecal contamination. Environment Agency vulnerability maps for the area also confirmed that groundwater was highly vulnerable to surface water inflow and therefore potentially at risk of *Cryptosporidium*. While UV is an effective control measure against *Cryptosporidium* it is only fully effective when the raw water being treated has a turbidity of less than 1NTU. Overall, the site visit confirmed that a combination of grazing animals

Tel: 0300 068 6400 Website: http://www.dwi.gov.uk and site geology and topography was leading to contamination and turbidity, and the latter was compromising disinfection.

- Stage One: source protection: Involved widening of the protection zone around the spring by installing a new rabbit proof fence at a distance of 4m and installing an impermeable lined diversion ditch along the fence line to divert surface and subsurface flows away from the source during heavy rainfall.

- Stage Two: catchment measures: Involved exclusion of sheep (livestock) from the wider catchment above the spring source by fencing a fan shaped area running 200m upslope and 100m across the top slope with a diversion ditch dug across the top of the fan to prevent faecal matter being washed into the protected area.

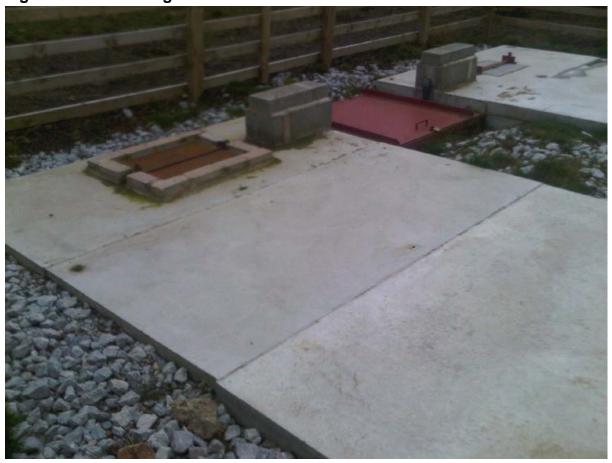
In 2008, *E.coli* was detected in a water sample and the directors and local authority undertook a joint inspection of the water holding tanks, whereupon it was found that the concrete had become porous allowing ingress of surface water into the tank. These tanks were replaced the following year (see Figure 13).

Figure 13: New storage tanks

- Stage Three: water supply asset improvements: Involved enclosing the relief valve on the storage tanks and raising the covers on the tank roof to give an upstand to prevent ponding of rain and seepage under the cover and joints. Additional works specified were removal of any redundant pipes and installation of a turbidity monitor that would trigger diversion of turbid water to waste and activation of the back up borehole supply. The final step, if needed, related to extending the contact time available for chlorination.
