PRIVATE WATER SUPPLIES – CASE STUDY (2011/08)

Unsatisfactory water quality as a consequence of using an unapproved treatment system

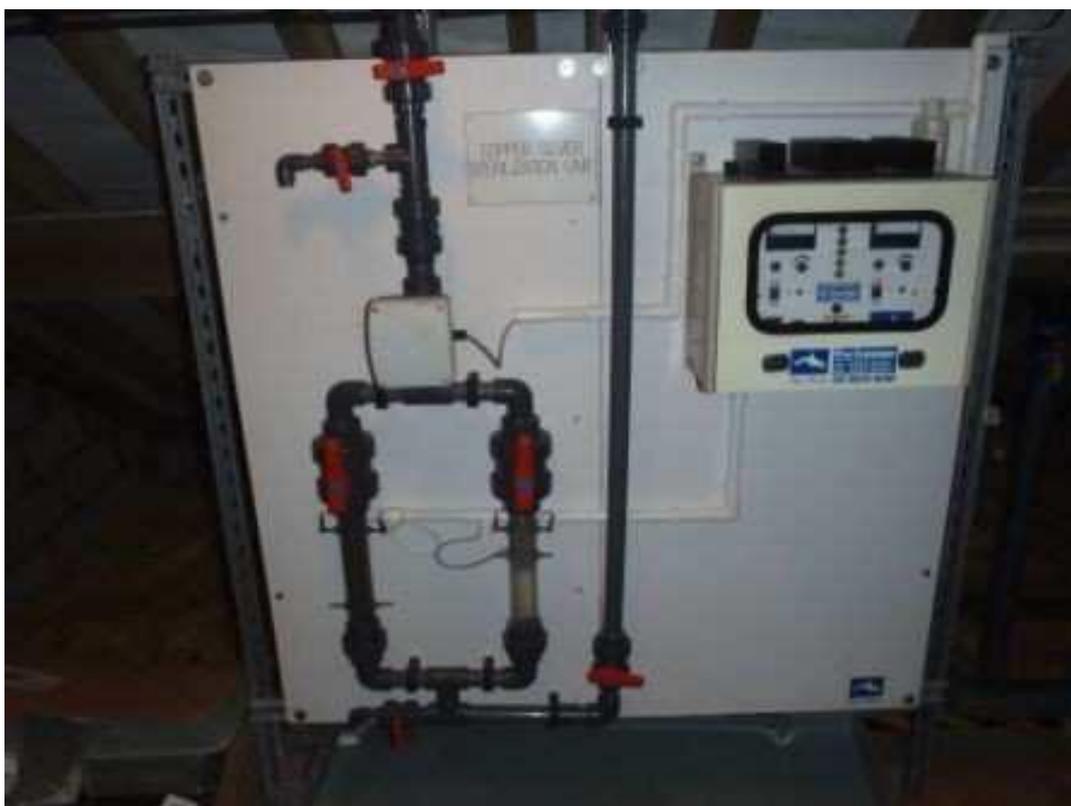
Copper/silver ionising system

Sampling by the local authority to inform the risk assessment had identified elevated turbidity levels in the treated water with a mean of 2.0NTU and a maximum of 7.2NTU. Initially the local authority had considered these unsatisfactory results might be indicative of fluctuations in raw water quality not being controlled adequately by filtration. The owner had been advised by their contractor to consider replacing the cartridge filters with sand filters and a quotation for such improvements had been obtained and was in the order of £10,000. However, following identification of the breach of Regulation 5 by the local authority, the Legionella control system was isolated from the water supply and this action resulted in an immediate improvement in treated water turbidity results (fell below 1NTU). At this stage both the local authority and the owner of the supply realised that the cause of the elevated turbidity had been the deterioration of the silver and copper electrodes in the Legionella control system.

By complying with Regulation 5, water quality was restored and the owner did not need to make expensive improvements to filtration, instead it was necessary only to replace the old cartridge filters for new ones, installing these in series and in transparent housing. These minor improvements minimised the likelihood of heterotrophic bacterial growth in standing water and facilitated visual inspection and effective maintenance (in accordance with best practice for Legionella control in cold water systems published by the Health and Safety Executive).

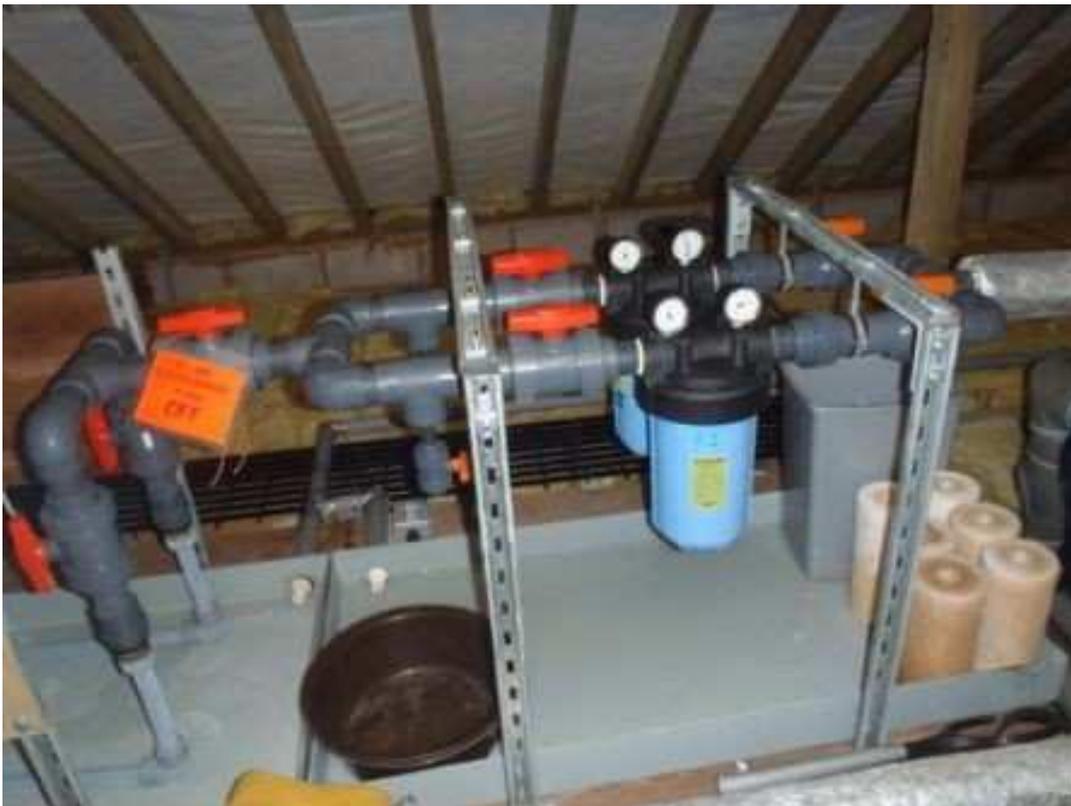
Filter arrangements showing spent stained cartridge filters (bottom right)
