Water Quality Compliance Monitoring

Water quality at treatment works

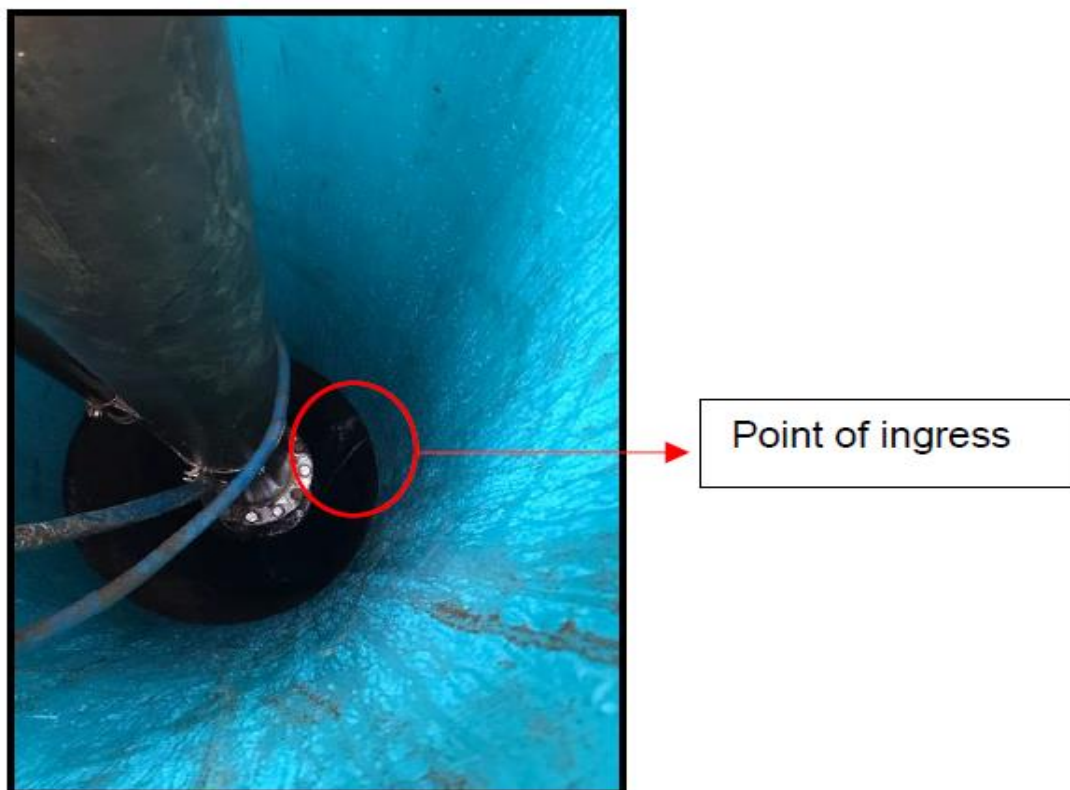
During September Yorkshire Water detected *E. coli* at Great Heck No2 works. Although initial investigations suggested that disinfection by UV and hypochlorite dosing had not been compromised, the company removed the site from supply proactively. The headworks had been originally constructed

in subterranean chambers but was raised in 2016-17 to bring them above ground level in order to reduce the risk of inundation by flood water. It was this work that upon investigation was found to have been leaking into the borehole. Significant ingress was identified from the flanged connection on the headworks which is below ground. Levels of *E.coli* were >100/100ml which is an unacceptable risk even with UV disinfection. It is disappointing that the very works intended to protect against ingress was in fact the very cause of the failure. The company response was to remove the works on discovering the failure, putting public health first and should be commended. Root cause analysis by the company in future could well focus on how to prevent retrofitting improvements from creating hazards to water quality. The works remains out of supply while remedial works are carried out. The company have sent pictorial evidence of the point of ingress (see below), which has been repaired and will be tested within a target date of reinstating the works during January 2020.

Figure 1: Ingress within the head works at Great Heck No.2

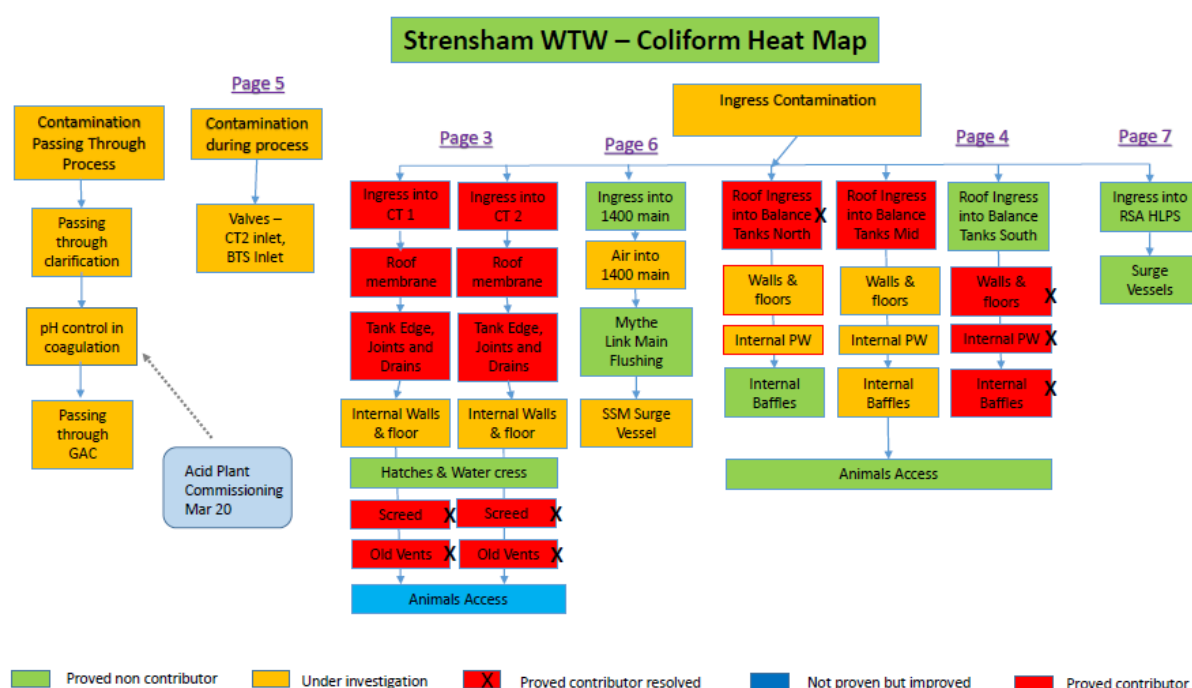
As part of the investigation into repeated bacteriological investigations in treated water from Strensham works, Severn Trent Water has methodically investigated the role of ingress into treated water assets, establishing which parts may be subject to ingress. A summary of this investigation, as provided by the Company, may be seen below and is an example of good practice in investigating a long term water quality issue.

Figure 2: Microbiological heat map at Strensham works

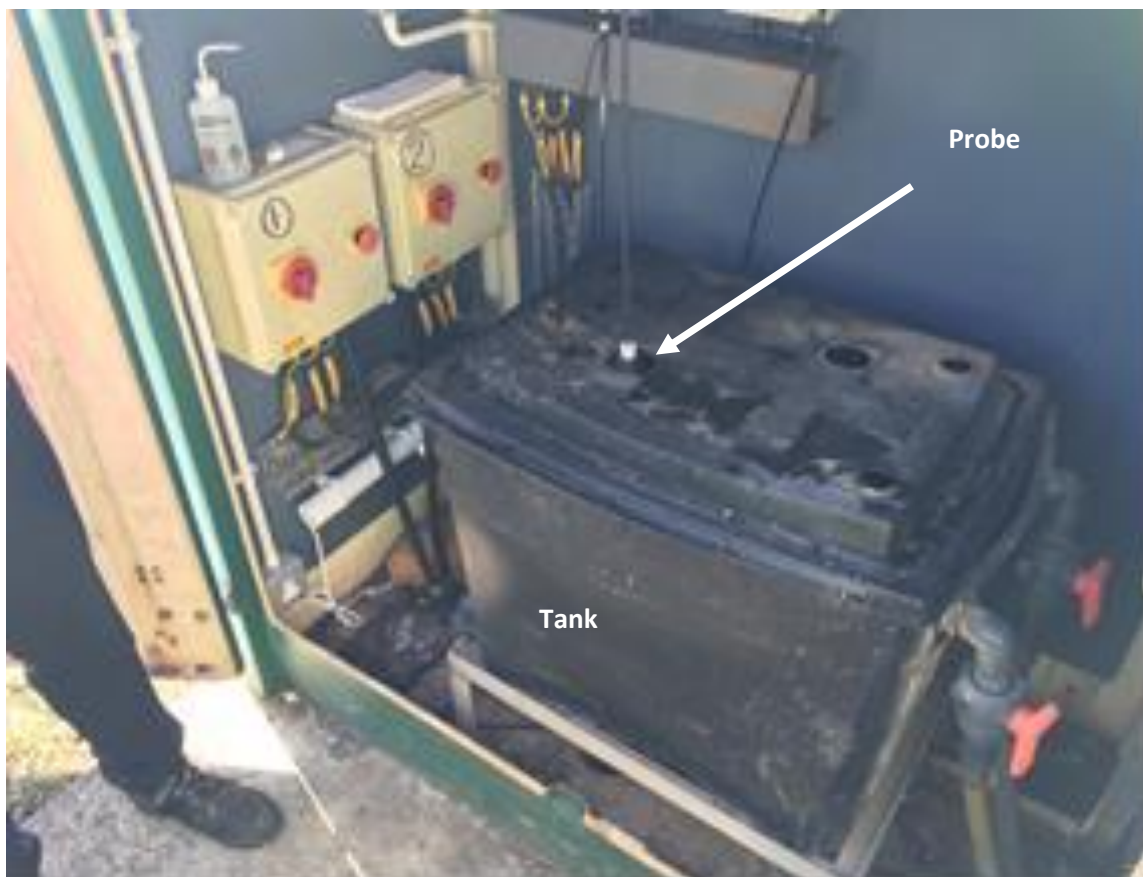
Following an event at Affinity Water's Iwer works, the Inspectorate recommended improvements to the process returning supernatant water to

the head of the treatment works. The turbidity reading at the time of the audit exceeded 10 NTU, a value in excess of recognised good practice, (Twort et al), this value applies if the return is <5% of the raw intake. (Lower values of <5 NTU were suggested by Logsdon, 1998). However, the arrangement was likely to be unrepresentative as the monitoring arrangement comprised of a turbidity probe located in a break tank on a pumped sample line (fig. 3). Sediment is likely to accumulate in the bottom of such a tank which when disturbed, for instance by opening the cabinet doors, will cause an erroneous reading. The company installed a new monitoring kiosk (fig. 4).

Figure 3: Sample tank for supernatant turbidity monitor at Iver works

There are currently no clear means to remove turbid water at this stage on this site and should the supernatant return exceed 10 NTU only a short period of suspension of return is possible. Such an arrangement presents an ongoing water quality risk should there be for instance of *Cryptosporidium* oocysts in supernatant return as this will overload the treatment processes rendering the works effectively inoperable. The absence of a run to waste facility at Iver works, which has variable raw water quality presents a significant risk. A recommendation was made for the company to install an intercept, containment, discharge or run to waste system as appropriate to protect public health.

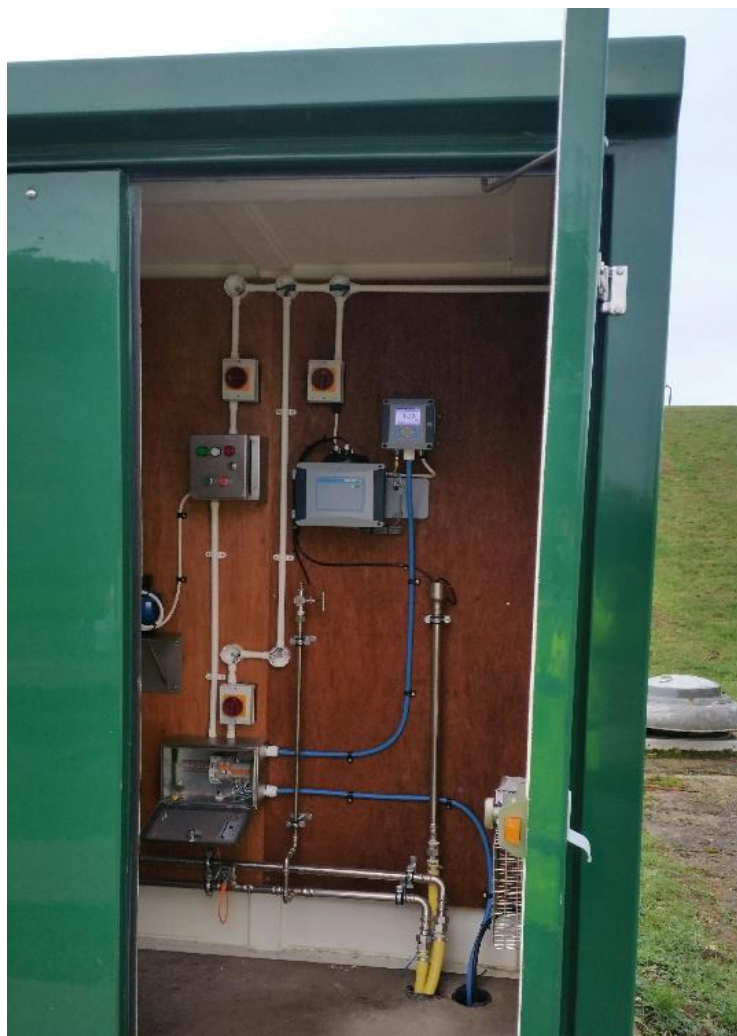
Figure 4: New supernatant turbidity kiosk at Iver works

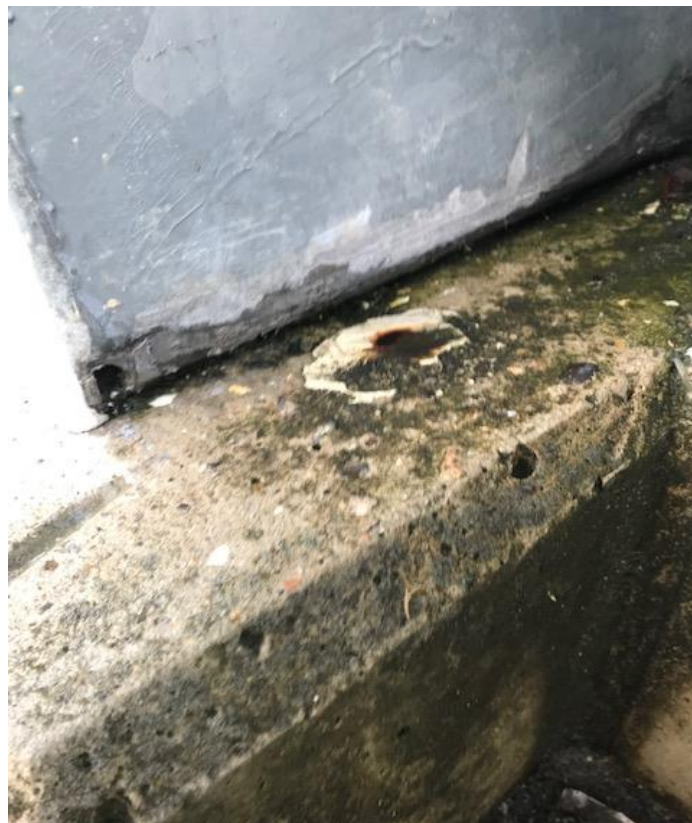
Since assets are under the control of water suppliers, no additional risk should be added due to a failure to adequately operate or maintain an asset. At Thames Water’s Chingford works it was noted that hatches were suitably secure and positioned on adequate concrete upstands. However, it is disappointing to observe a missing seal with water staining from the top of the hatch downwards suggesting possible ingress in light of the missing seal (fig 5). Similarly, a hatch, which contained a sample line, was around 20cm deep in water within the interior and the point at which the line and cabling entered was not sealed. Three open holes (approx. 0.5 to 1cm in diameter) were observed on the plate potentially permitting access to insects. Recommendations we made in both cases.

Figure 5: Missing hatch seal on Chingford Contact Tank

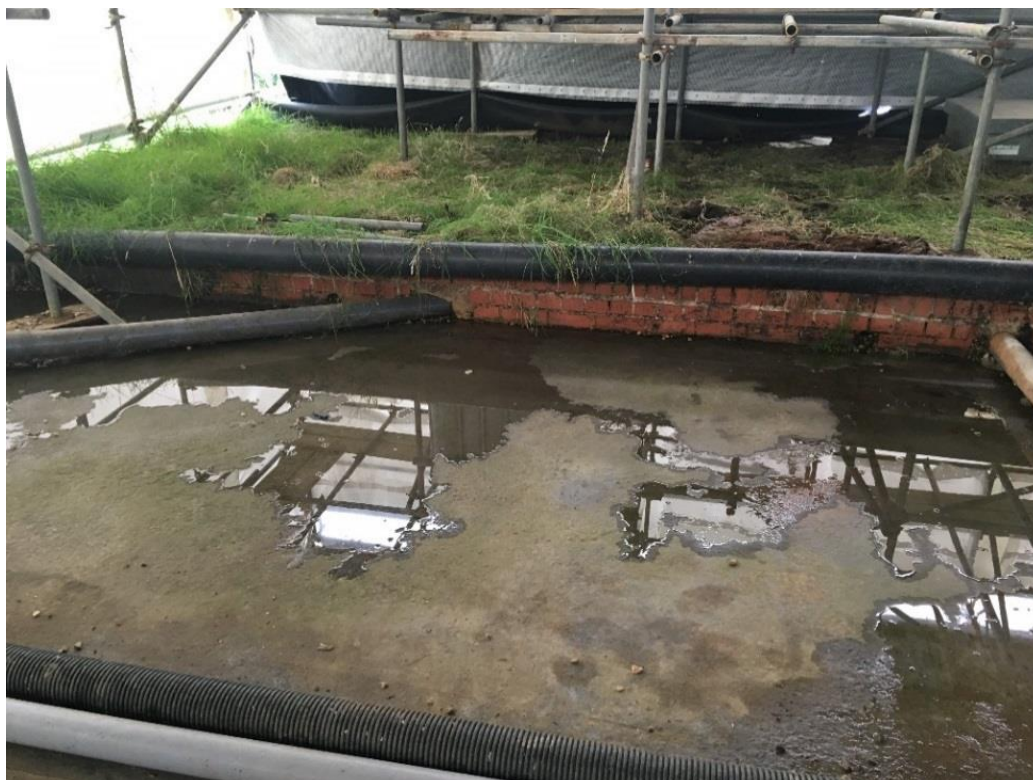
Southern Water installed a frame and plastic covering over the contact tank at Sandown works, as a temporary mitigation to address known leaks in the roof. The covering was ineffective with water still pooling on the tank roof (fig. 6). It would be reasonable to question why ongoing maintenance had not prevented leaks in the contact tank roof. Notwithstanding this, mitigation in response to a leaking roof might well be to fix the roof as a high priority. The Inspectorate recommended that the company reviews the drainage and prevents pooling on the tank roof in the interim.

Figure 6: Ongoing run off of surface water onto Sandown's contact tank roof

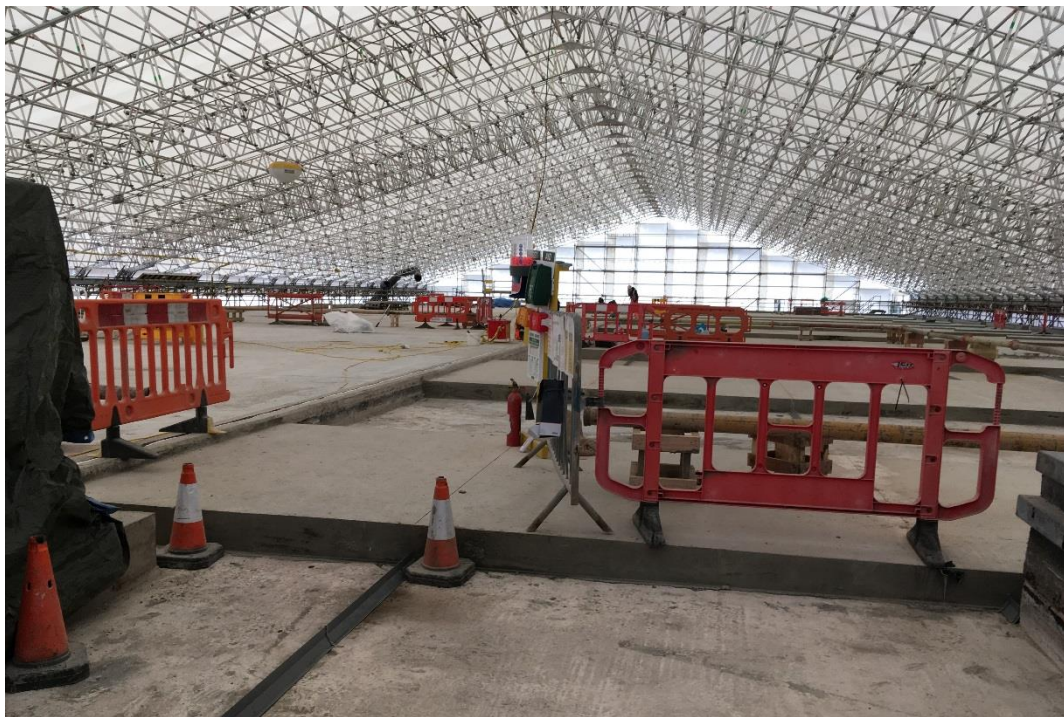
Severn Trent has had a number of bacteriological failures at Strensham works attributed to ingress. Historically, ingress has been remediated by repeatedly patching the roof with more concrete. Such a strategy might be questionable as it proved to be. Over the years the integrity of the walls of the contact tanks were compromised as the extra concrete load on the roof exceeded the design load capacity of the walls. The contact tanks have been covered with a 'tent' to mitigate bad weather risks, whilst longer term repairs are completed (fig. 7). About 2,000 tonnes of additional concrete is being removed from the roof to bring it back within the design specification. Electric diggers rather than conventional ones are being used to eliminate the risk of fuel spills. A salient lesson as the additional cost to the company

could well be in excess of that had the roof been repaired properly in the first instance.

Figure 7: Protective cover over the contact tank at Severn Trent's Strensham works

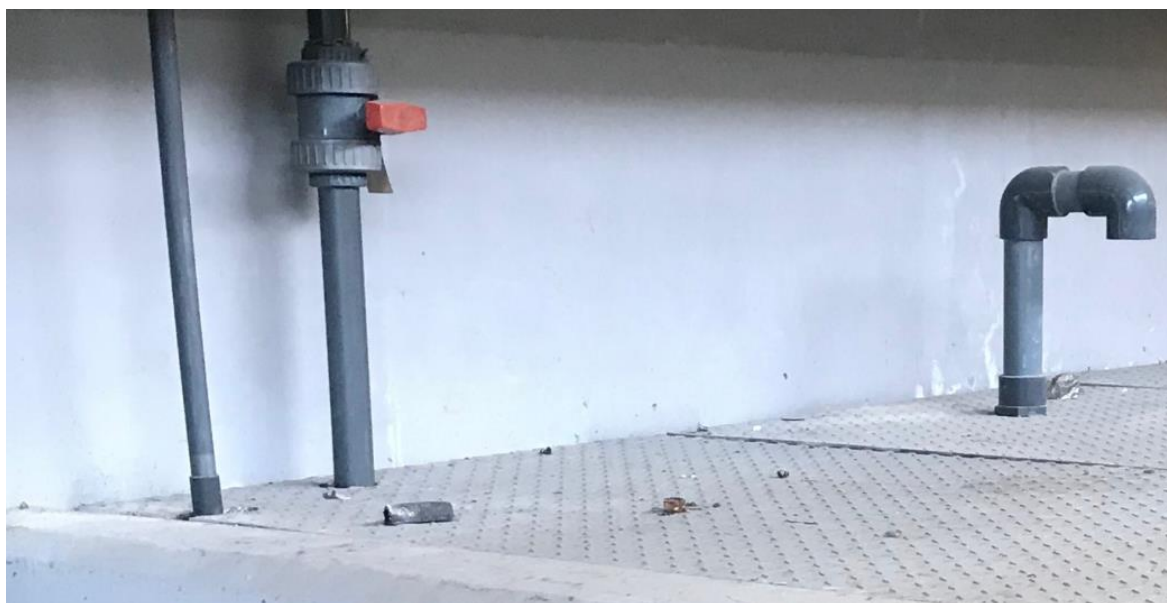
At Iwer works (AFW), the filter outlet channels were covered in warped and poor fitting steel chequer plates (fig. 8). Recommendations were made. The design of Iwer works is such that the backwash tank is located beneath the filters. This is not an unusual configuration as designers seek to reduce the footprint of works by stacking process stages. More common is the location of a contact tank under the filters. This design saving is still used in recent builds and should be considered as designing in additional and unnecessary risk. When the concrete deteriorates with age leakage from the filter to the tanks below can occur and has been observed in older works. This effectively bypasses the treatment process and will inevitably lead to a water quality risk. Affinity Water have not included the old backwash tank at Iwer works on their internal inspection programme since it is situated beneath the filters and difficult to access.

Figure 8: Debris and poor fitting plates above the filter outlet channel at Iver works

Without an inspection the company cannot conduct a complete risk assessment. Whilst the company acknowledge that an inspection would make the risk assessment more robust they have chosen not to complete this. Instead, the company are considering the inclusion of another back wash water tank in the scope of treatment improvements at the works scheduled for AMP7.

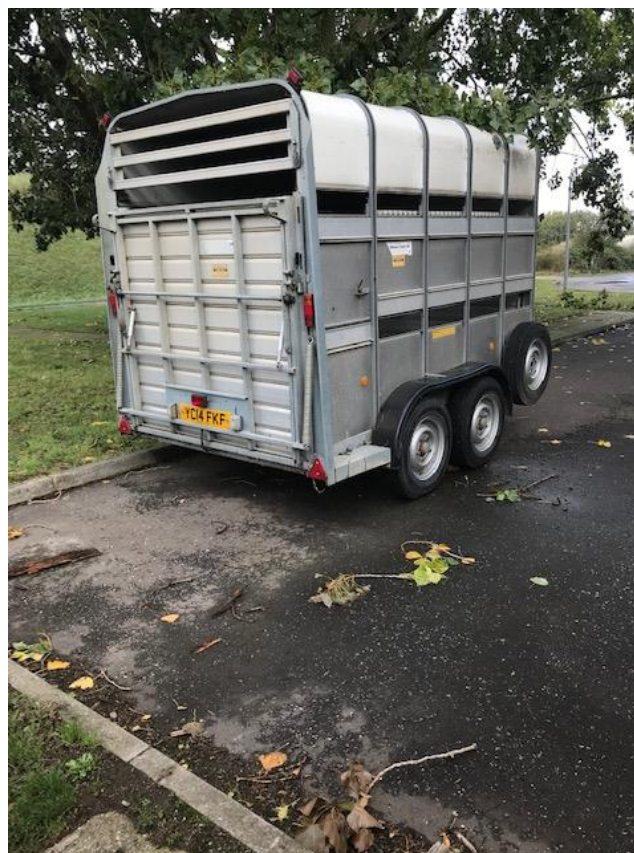
Badenoch 1990 when referring to service reservoirs stated that the grazing of grassed roof covers by livestock should be discouraged. He observed that ingress of oocysts pose a particular risk when no further treatment barrier exists. The use of sheep for grazing near raw impounding reservoirs and other non-treated water areas is well known and utilises an otherwise unused green resource, provided this does not add unnecessary risk. However, a livestock trailer (fig. 9), parked in the grounds of Chingford works was assumed by Thames Water to belong to the local farmer for the purposes of transporting sheep. Whilst the presence of the vehicle on site does not itself present any direct or immediate contamination risk, given the link between sheep and waterborne parasites, its presence on a restricted clean water site does raise a question as to why it is there.

Figure 9: Sheep trailer in restricted area at Chingford works

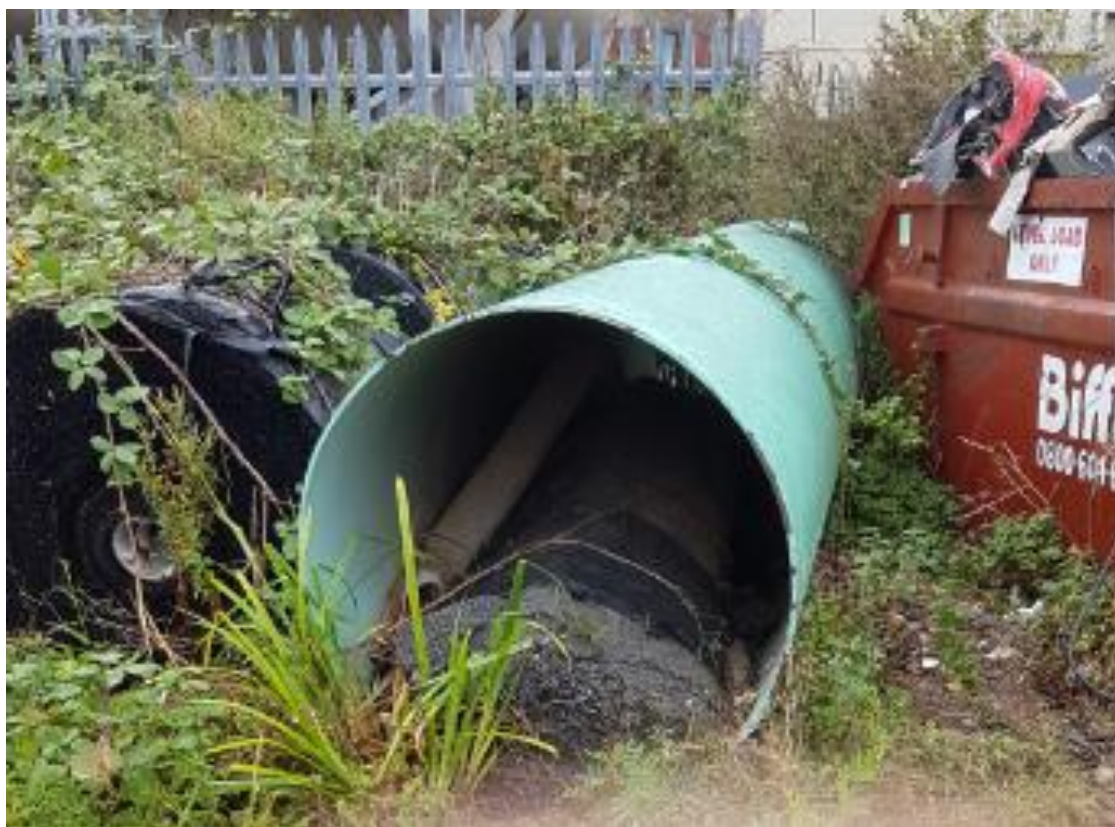
The maintenance and hence appearance of a water treatment works should always be in keeping with a site which provides a food product. Chingford works was on the whole well maintained. It was somewhat let down by a large diameter pipe left near the refuse point (fig 10). It was indeterminate whether or not it was for disposal. Additionally, a ground maintenance contractor's chemical storage box was found to be unlocked, representing an un-controlled risk. In the interests of safeguarding against any unnecessary spillages or pollution risks on site, the Inspectorate recommended that

Figure 10: Discarded pipe at Chingford works

refuse points, containers and overall waste disposal arrangements are reviewed and improved.

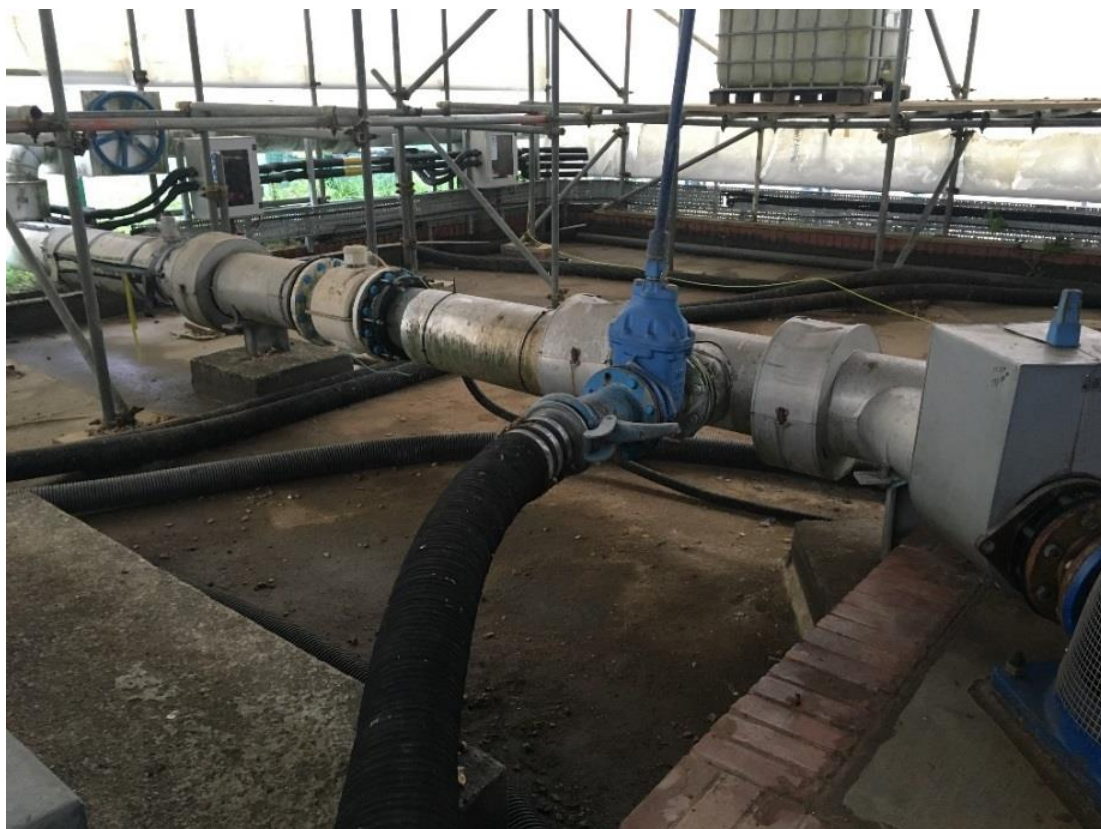
the installation of the run to waste pipe was well intentioned in allowing improperly treated water to be removed from the supply system, it was poorly executed on this occasion. A simple fittings inspection would have identified this unnecessary risk.

Figure 11: Temporary hose connected to treated water main at Sandown works

It is important that such temporary alterations to treatment works are appropriately risk assessed by those with the competence to ensure water quality and public health are protected.

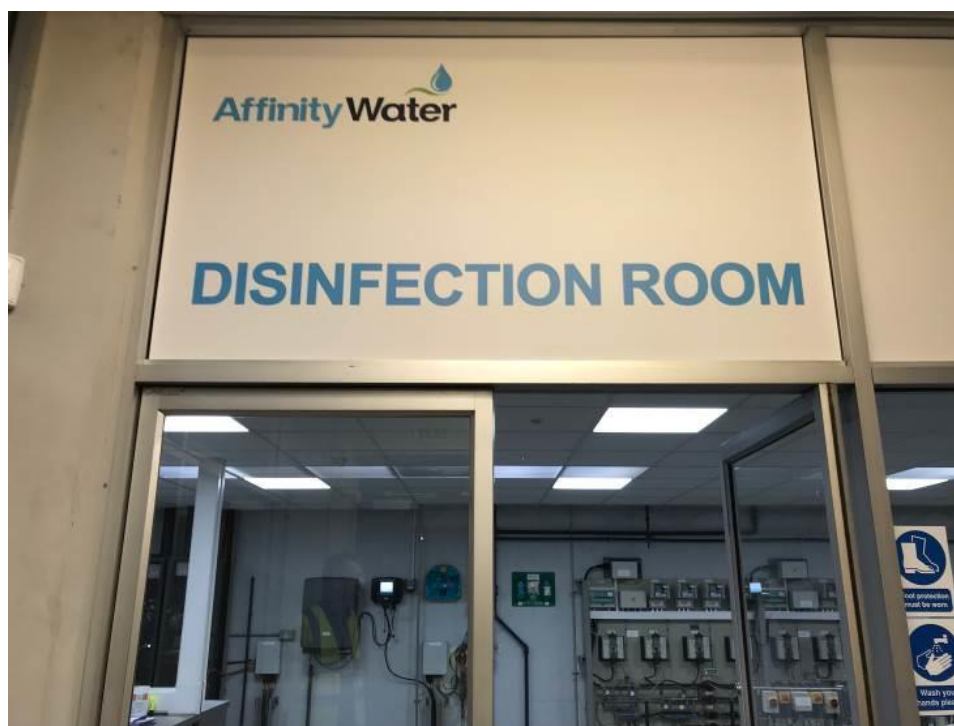
The Inspectors welcomed the development of a dedicated Disinfection Room for WQ instrumentation including chlorine dosing control, turbidity and a dedicated bench testing area at Iver works (AFW).

Figure 12: Dedicated Disinfection Room at Iver works
