Drinking water 2018
Public water supplies for
England and Wales

Quarter 3
July – September 2018

Published by
Drinking Water Inspectorate
Nobel House
17 Smith Square
London
SW1P 3JR

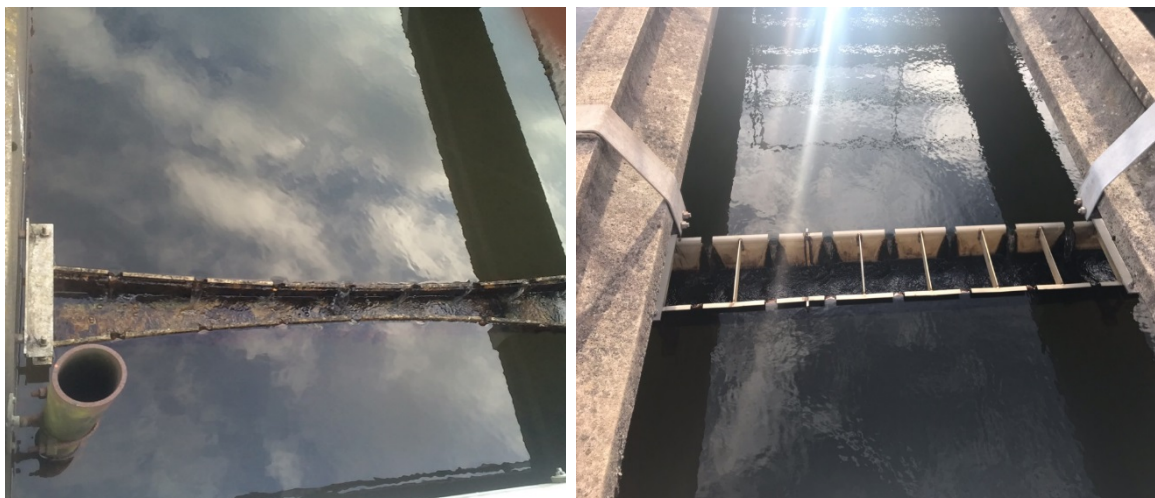
Dŵr Cymru Welsh Water were completing a programme of replacing the glass reinforced plastic (GRP) launders on the clarifiers with stainless steel.

Figure 1: Warped GRP Launderers (left), Replaced with Steel at Sluvad works.

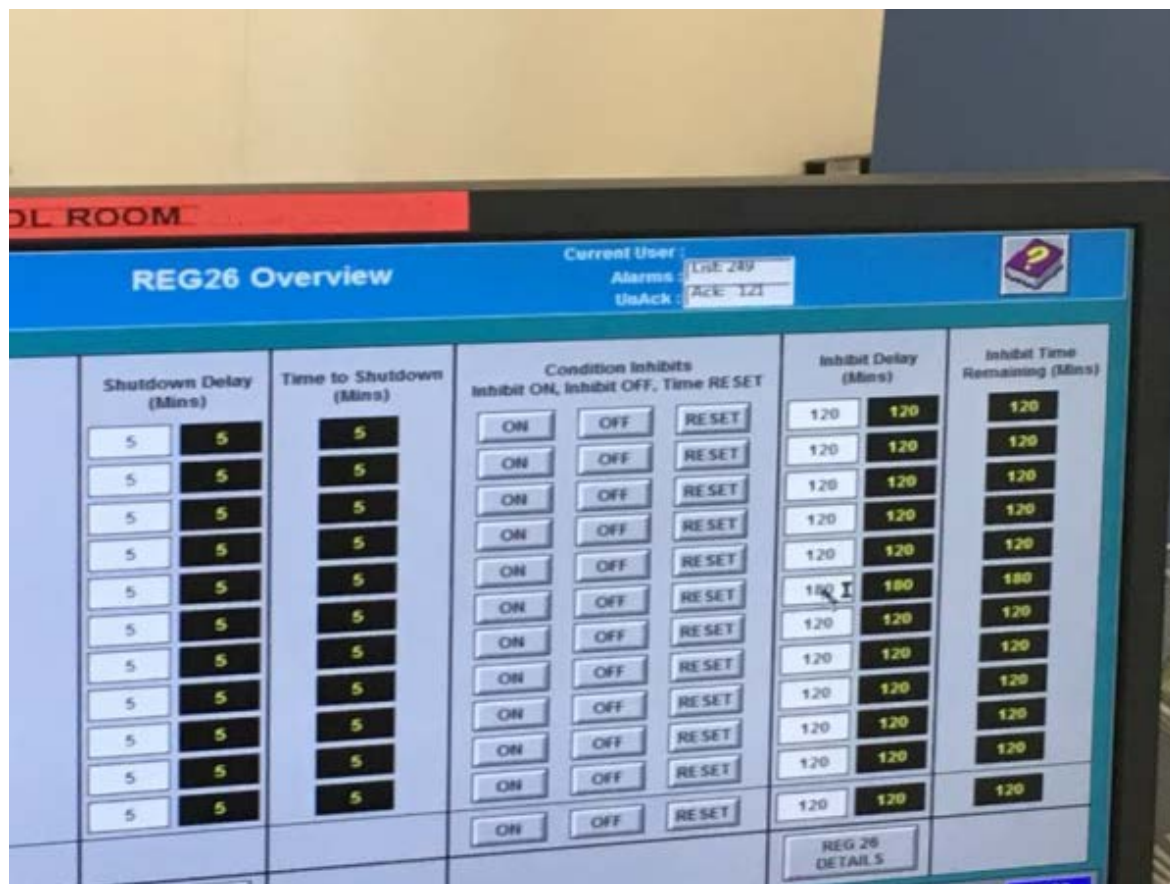
Inhibit timers form part of the alarm operation system at United Utilities' Sutton Hall works. The inhibit timers can effectively override the water quality failsafe shutdown systems at the works and extreme caution should be used when using such systems. It is not appropriate for improperly treated water to be supplied to consumers and Regulation 26 makes specific requirements related to a company's obligations in such circumstances. The company's site specific disinfection policy makes no reference to the conditions when inhibit timers may be used. It was reported that when they are used this would be for a maximum period of two hours. It was observed at the audit that a number of the inhibit timers were set in excess of this limit and these were hastily reset when this was pointed out. There is also no restriction on the number of times the inhibit timers can be reset or an effective upper time limit. This could lead to the wilful or inadvertent override of all water quality safeguards at the works. Whilst it is understood that there may be circumstances when it is necessary to override alarms for a short period, for example during treatment works start up, the use of overrides needs to be scrupulously controlled and their use avoided whenever the water is being supplied to consumers.

Figure 2: Alarm Inhibit Timers at United Utilities' Sutton Hall works

Similarly, the company has in place a 'maintenance switch' which effectively overrides alarms to allow instrument maintenance and calibration to take place. In the 365 days leading up to the audit the switch was used on 163 occasions at Sutton Hall works compared to an average of 7.3 times in the same 12 month period across the other 123 sites with a maintenance switch. This implies a culture of overriding alarms at Sutton Hall, which has neither been identified nor addressed by the company and calls into question the management of this site and independent safeguards the company may have in place to ensure its policies and procedures are adhered to. Following a re-briefing on the procedure for use of the maintenance switch the company reported it had not been necessary to use it at all in the following three month period. United Utilities introduced a new procedure to independently check that maintenance switches and shutdown overrides were being used appropriately.

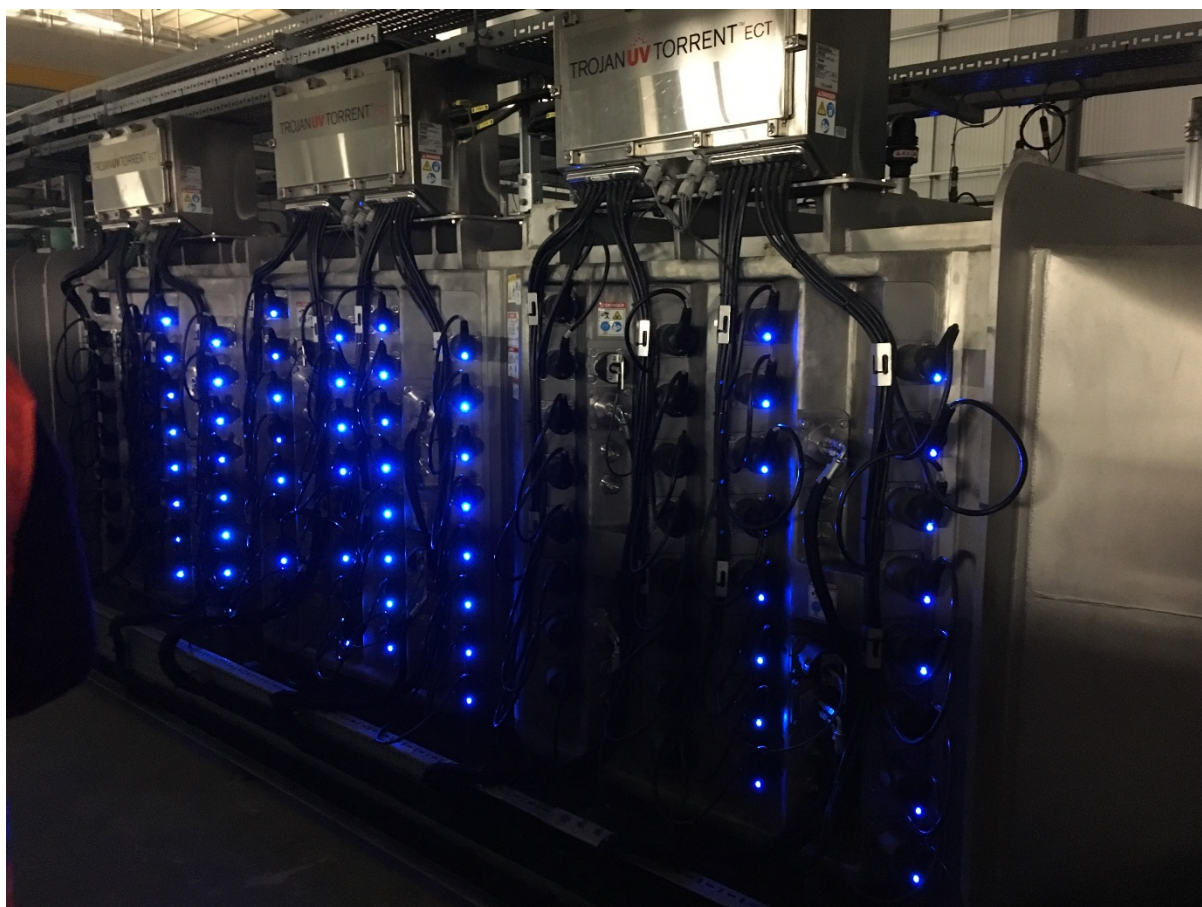
The next process at Hall works is advanced oxidation (AOP) using hydrogen peroxide and UV to treat difficult to remove pesticides such as clopyralid and metaldehyde. While the process is effective in removing these pesticides it was unclear whether the company had fully considered the other likely impacts of this process including the implications for disinfection by-product pre-cursor formation and the Inspectorate recommended that the company set appropriate inter-stage targets to ensure the water was adequately prepared for disinfection.

Downstream of the AOP process at Hall works are the GAC polishing filters, which are used for taste and odour removal and quenching of any excess hydrogen peroxide from the AOP process. Anglian Water were not able to demonstrate that the hydrogen peroxide had been quenched as required by Regulation 31 or that there were appropriate water quality targets for this treatment stage.

Figure 3: The Advanced Oxidation Process at Anglian Water's Hall works.

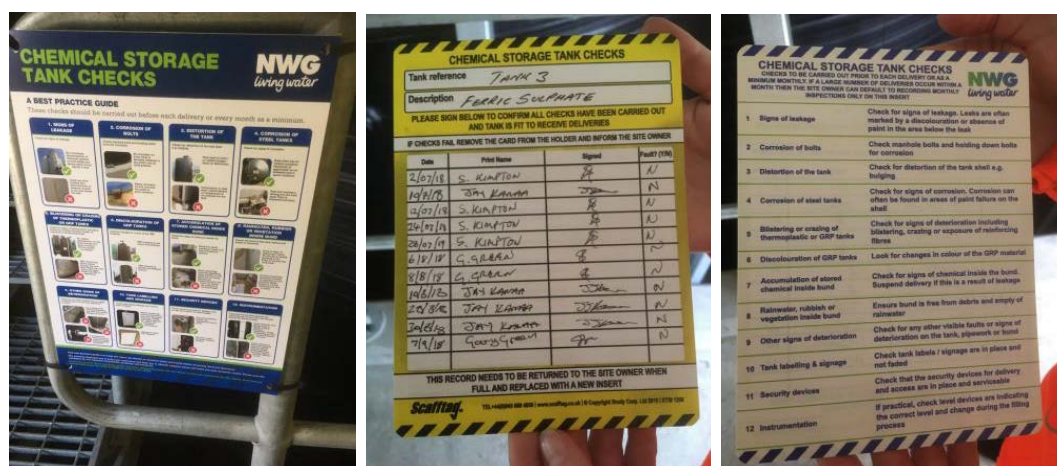
At Essex and Suffolk Water's Hanningfield works, the Inspectors noted the system of chemical storage tank checks to ensure that the tanks were in good condition and able to accept a chemical delivery, the positioning by the tanks themselves can also be a good prompt to carry out and record the task.

Figure 4: Good Practice. Chemical storage tank checks at Hanningfield works.

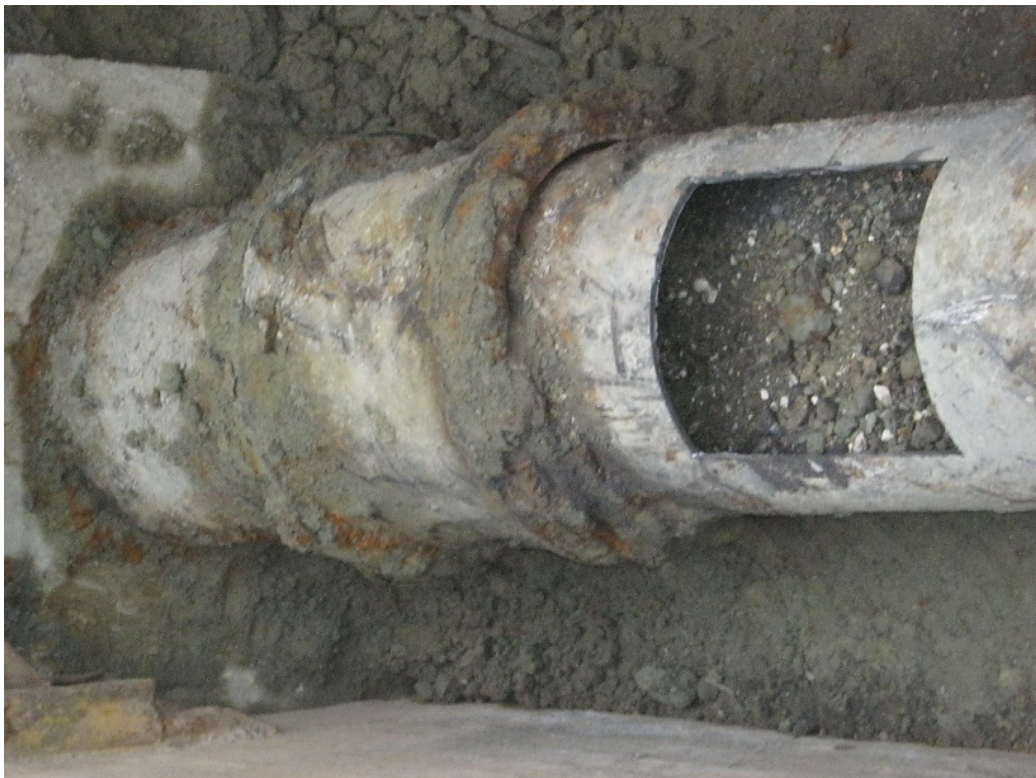
An investigation by Southern Water, after the event, concluded that a drilling operation at the site caused damage to an outlet main, the ensuing leak caused landslips and joints in the inlet and outlet mains pulled apart leading to ingress into the reservoir and subsequently discoloured and highly turbid water was supplied. The photograph below shows the quantity of soil that entered the inlet pipe. It was taken by the company while investigating the incident.

Figure 7: Soil ingress in the inlet pipe of Cooks Castle service reservoir.

did not issue advice to boil water. Given the sequence of leaks that had occurred at the site, that water was gushing from the area of the inlet main and that the reservoir contained elevated turbidity, it was reasonable to assume that there had been ingress of some amount of soil into the system. The resultant turbid water would have flowed into supply from the reservoir. After isolation of the reservoir there may have been a further supply of turbid water to Wroxall from any soil within the inlet main or gaining access via the break in the inlet main.
