Drinking water 2020

Quarter I

A report by the Chief Inspector of Drinking Water

Drinking water 2020
Public water supplies for
England and Wales

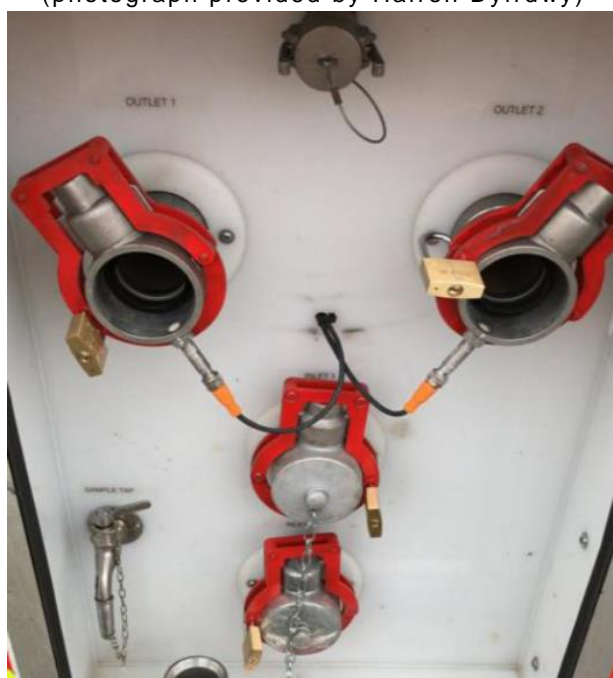
At around 07:30 the same morning, an employee arriving at the depot in Warwick noticed that a tanker that should not have left site was missing. This tanker was part-way through being cleaned and disinfected and contained highly chlorinated water - approximately 32 mg/l of free chlorine.

The company found that the procedure for cleaning and disinfecting tankers at Warwick had not been followed correctly. The arrangements for ensuring that tankers undergoing disinfection were not deployed for use by mistake were insufficiently robust to prevent this from occurring. Furthermore, it is likely that at least one of the tanker drivers fabricated the results of the on-site chlorine test at Llangurig, because if this test had been carried out correctly, the result would have been abnormal. The company was unable to complete its investigation into this because the tanker driver resigned but has strengthened its procedures and carried out refresher training for relevant personnel.

Figure 1 –Tanker inlet and outlet locks
(photograph provided by Hafren Dyfrdwy)

All water companies should ensure that robust risk assessments are carried out whenever reservoir replenishment and direct injection into the network are required to maintain supplies. Risk assessments should be based on accurate records and distribution models and give sufficient regard to drinking water quality risks. Tankering operations should not increase the risk of discoloured water being supplied to consumers, and direct injection into distribution mains should not increase the likelihood of further bursts. Procedures for ensuring that mobile tankers that are off road for cleaning and disinfection should include physical security measures, for example to prevent the tanker from being driven and to lock off filling and discharge points.

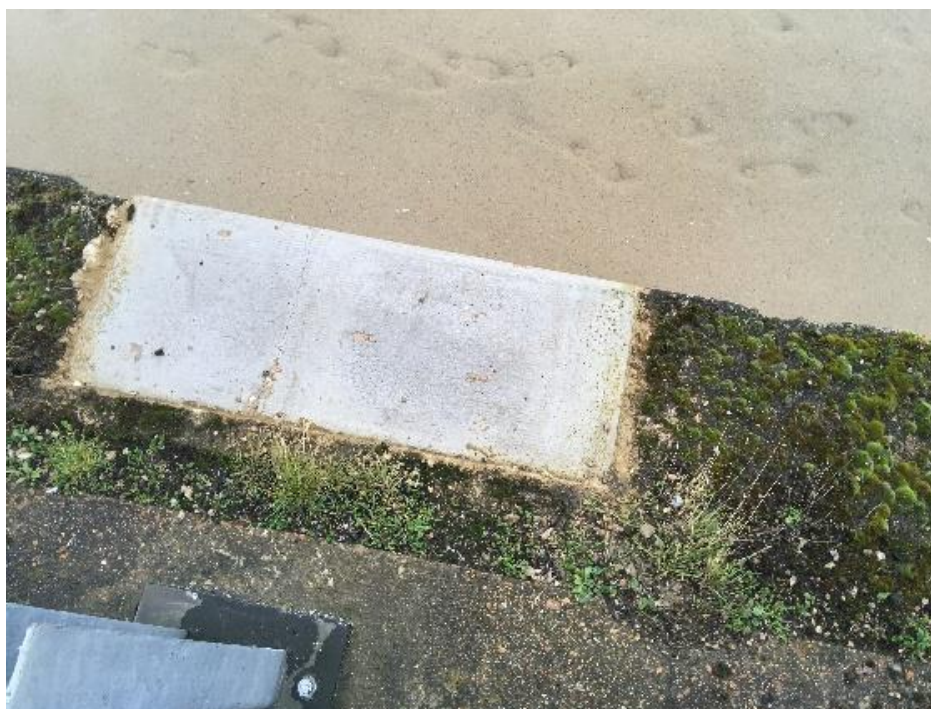
Figure 2: Repaired coping stone among excessive vegetation at Ashford Common works

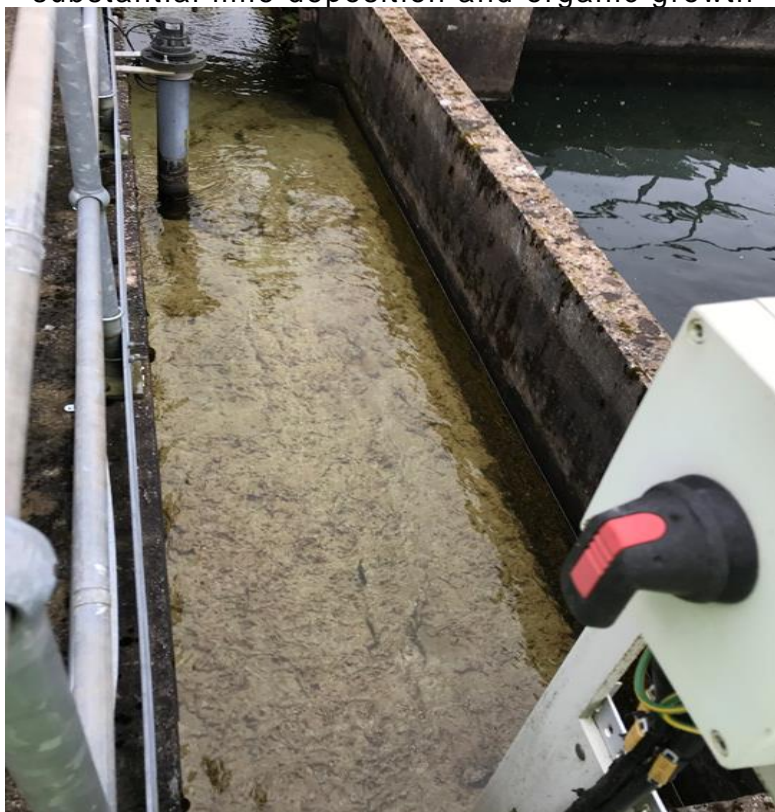
The chemical dosing notice requires the company to 'provide a permanent upgrade of the lime dosing system'. A temporary Kalic system, which is a common trade name for liquid calcium hydroxide, is in use to dose into the post-clarified water. However, in an emergency the Kalic liquid lime can be used on the raw water. Substantial lime deposits and organic growth was observed in the rapid gravity filter inlet channel. The company plan to clean this during a planned works shutdown.

Figure 3: Fontburn rapid gravity filter inlet channel showing substantial lime deposition and organic growth

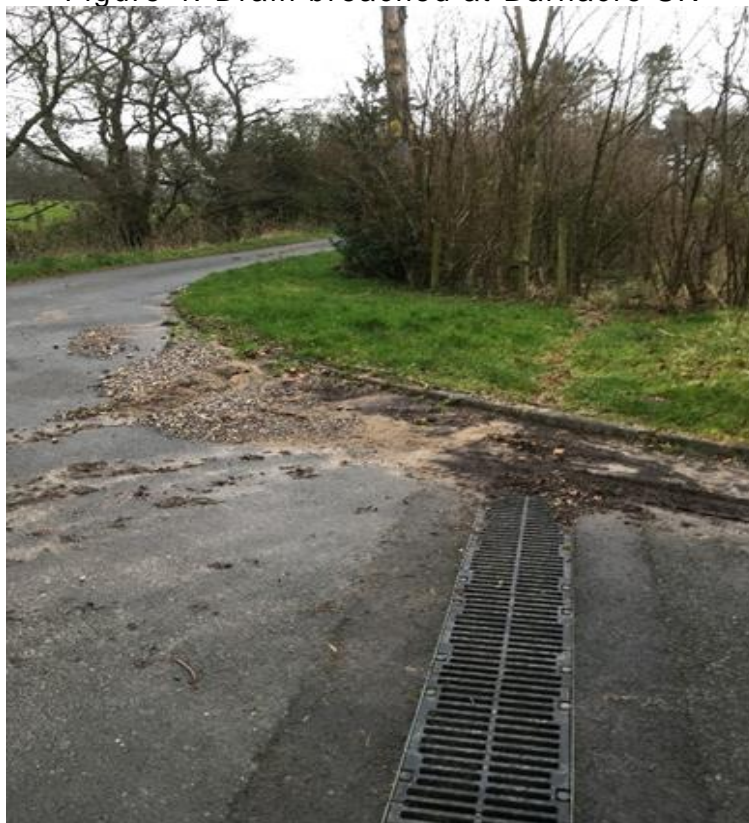
The most probable cause of the Franklaw event in 2015 was contamination of Barnacre service reservoir, due to run off from surrounding land. The flood defences of Barnacre were examined. A drain had been installed across the access road to divert water away from the reservoir roof, but this was partially blocked by sediment and leaves, washed down by storms Dennis and Ciara. Such a critical asset should be regularly maintained and inspected following heavy rainfall. Faecal risks close to the reservoir were unquantified. There is the potential for run-off onto the reservoir in severe storm conditions. The Inspectorate recommended that this risk is critically assessed in the light of storm Dennis and further strengthened, to divert water away from the reservoir.

Figure 4: Drain breached at Barnacre SR

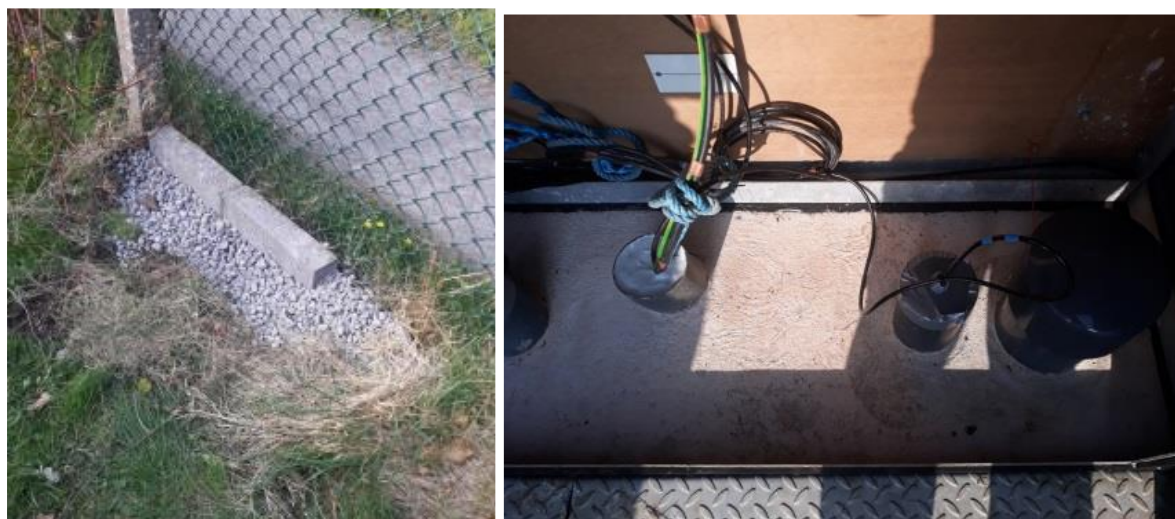
The company undertook a review of pest control measures and tank ingress risks at Cheddar works and acted to address the risks, including repairing fences, removing grass cuttings and discarded materials, sealing ducts and introducing regular checks for changes in ingress risk and planning to place gauze over the washout to prevent vermin ingress.

Figure 5: Fence repairs and sealed ducts among measures to address vermin risks at Cheddar works

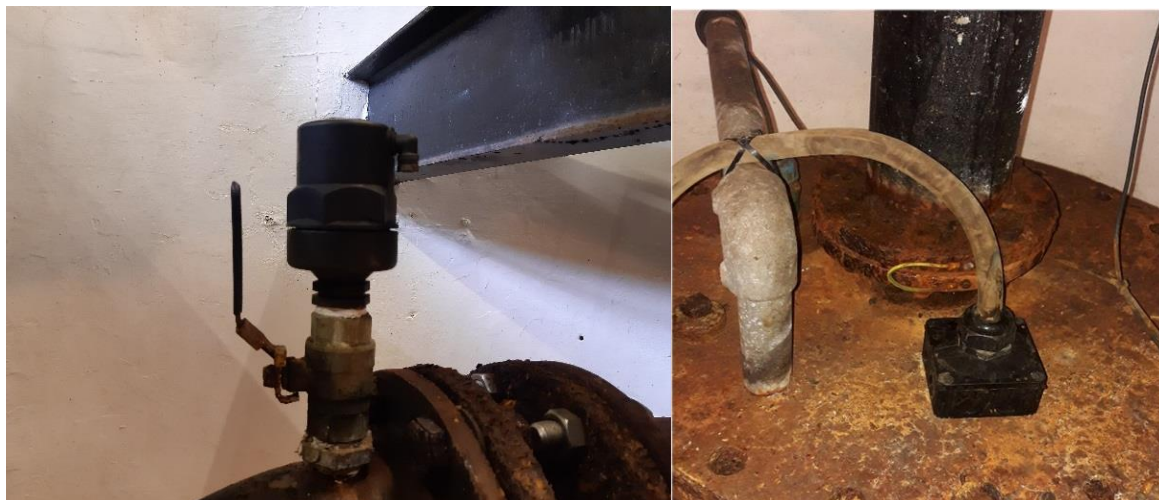
A recommendation was also made to address identified borehole contamination risks at Ford works, which the company duly rectified.

Figure 6: Air valve replaced, and gland fixed following the audit at Ford works
