Drinking Water 2022

Quarter 1 January – March 2022

A report by the Chief Inspector of Drinking Water

Public water supplies for England and Wales

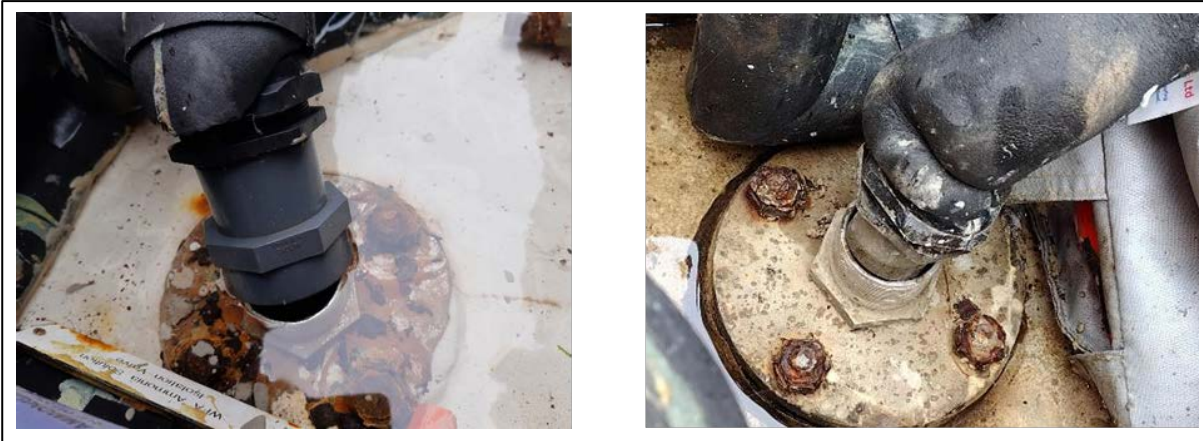
In February, Thames Water identified potential ingress around the ammonium sulphate dosing lines at Coppermills works. The company concluded this was the most likely cause of the coliform failure at the works. At the time of inspection, the dosing chambers were found to be flooded. As can be seen below, the dosing lines were not well sealed, and the flooding was likely caused by long term leaks on the pipework around the high lift pumping station. In addition, there is a risk that waste process water and surface water runoff contributed to the flooding.

Figure 1: Unsealed dosing lines at Coppermills works

Thames Water repaired the dosing points and minor repairs were subsequently carried out to address ingress into the contact tank.

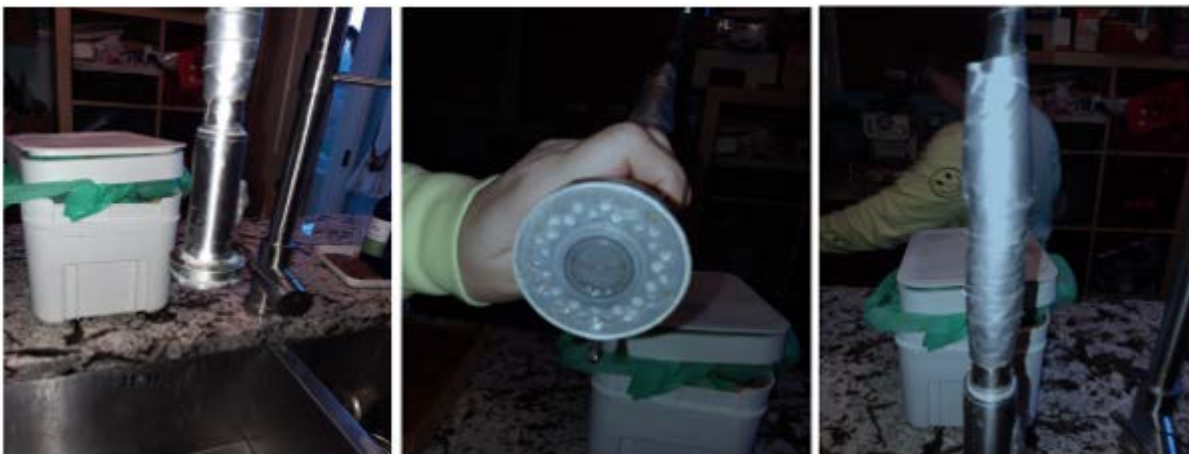
For Bristol Water, a regulatory sample failed for coliform bacteria and was collected from a mixer tap with a pull down hose with a sprinkler type head. The presence of small plastic nozzles on the pull down head posed a microbiological risk as organic particles and detritus can accumulate inside and around the nozzles. The flexible hose had also been noted as repaired by the consumer with duct tape to help patch a leak.

Figure 2: Photos of kitchen tap and hose

The Inspectorate reminded the company of the requirements of part 6.4 of ‘The Microbiology of Drinking Water (2010) – Part 2 – Practices and Procedures for Sampling’ that states “taps at domestic properties should, ideally, be in good repair and should supply water from a pipe connected directly to the water main”.

A recommendation was raised under regulation 16 for the company to review the training and guidance given to samplers on the appropriateness of taps used for regulatory sampling purposes to ensure samples collected are representative of the quality of the water being supplied.

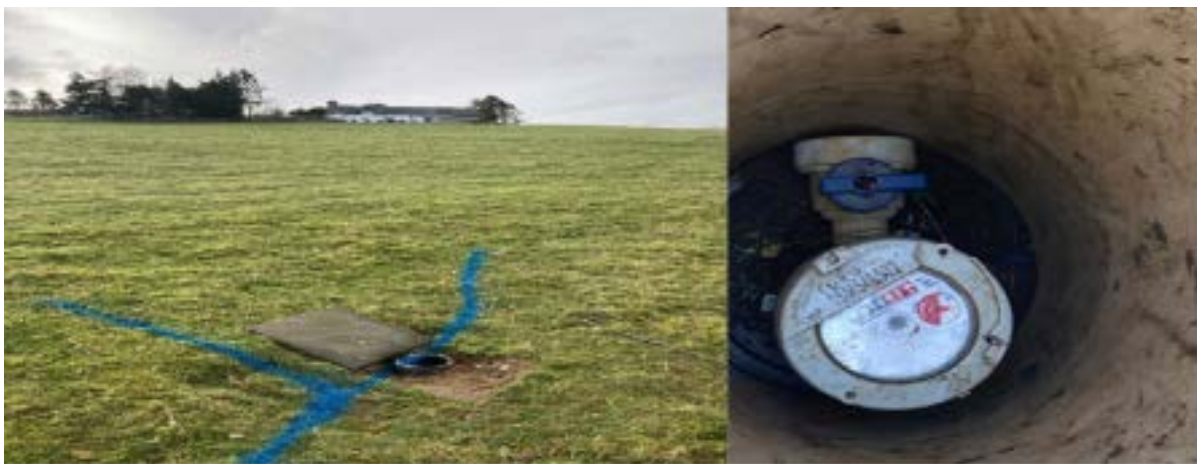
In January 2022 Dwr Cymru Welsh Water identified that the booster pumps at Gaufron Water pumping station were not controlling as expected. A job to investigate this was raised, but this was not planned or undertaken until the following month. This found that the pressure in the network was higher than the output pressure from Gaufron pumping station and that residual chlorine readings downstream of Gaufron pumping station were low compared to the readings in the network. This anomaly was escalated and investigated further by the company. This revealed an ambiguous noise on the network, which was traced to a farm that had a connected spring fed private water supply. When this property was isolated from supply, the pressure dropped at Gaufron pumping station.

Figure 4: Cross connection point and meter

The Inspectorate concluded that the company's sampling response was inadequate as it was untimely and unrepresentative of the water at the time of the event. Since other recommendations related to sampling inadequacies had already been made on several occasions prior to this event, an undertaking was served on the company to ensure that root causes and the extent of any failure is ascertained.

The company was also recommended to review and update its procedure on identifying any ambiguous or spurious data, (pressure readings in this case) to ensure that investigations are initiated promptly.

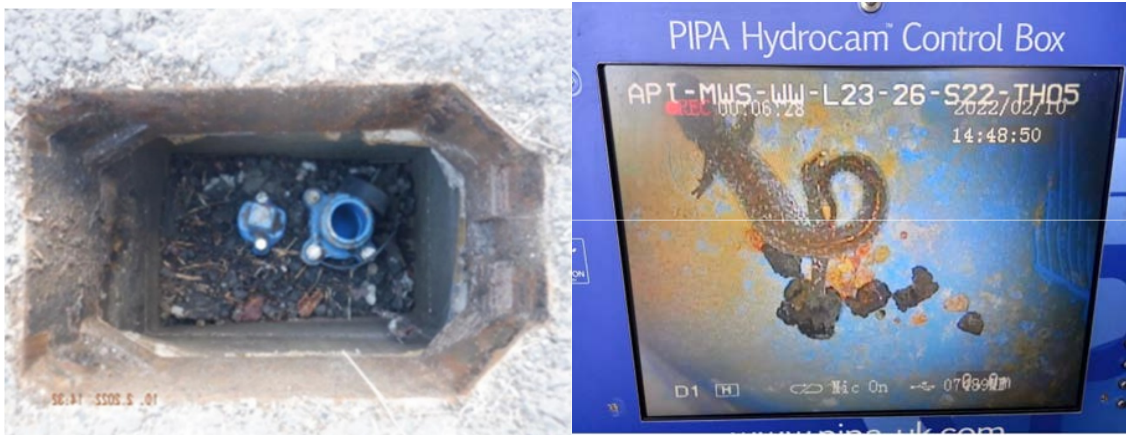
In February 2022, contractors working for Dwr Cymru, Welsh Water discovered a live newt in a water main during a CCTV inspection of the network in the Mitchell Troy area (Redwren zone) of Monmouthshire.

Figure 5: Hydrant chamber showing missing cap

Figure 6: Photo of newt observed during camera survey

This work was being carried out as part investigations to reduce discolouration risks and potential related to consumer contacts. This finding was reported by email to the company, but not acted upon until the following day when the matter was escalated and notified to the Inspectorate. The company removed the newt by flushing the main over a duration of 45 minutes, after which the animal was found to be dead. Routes of its access into the main were speculated but no definitive route was identified.

The Inspectorate concluded that the company's regulation 18 event sampling response was inadequate, and that it had failed to assess the potential risk to consumers for two days after the event. The assessment identified that whilst the contractor had carried out its own generic job risk assessment for the overall activity, it was not task specific and did not consider potential water quality hazards. The Inspectorate also concluded that the method statement for the job was not followed to the full and recommended that that a comprehensive review of all planned activities be carried out to ensure that in future water quality risk assessments are completed for work of this nature. A further recommendation was made to develop an overarching procedure to manage camera surveys and to carry out regular checks against this procedure to ensure they were being adequately applied.
