Drinking Water

Quarter 2 April – June 2022

A report by the Chief Inspector of Drinking Water

Public water supplies for England and Wales

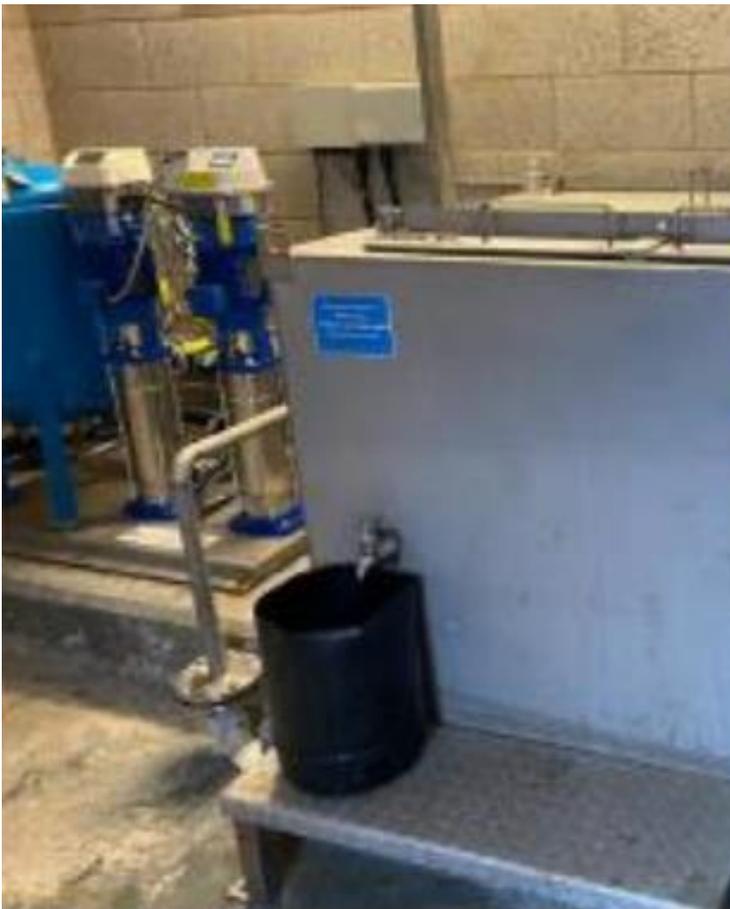
Figure 1: Yorkshire Water regulatory sample point tundish at Stockdale Farm service reservoir

In May 2022 Yorkshire Water detected repeat compliance failure from Stockdale Farm service reservoir. As a site where a failure was also detected in August 2019, a robust investigation is always required to assure water quality. All resamples were satisfactory for bacteriological parameters, but an investigation into the upstream pumping station showed the potential for the inlet pipework to become depressurised. Although the determination of a direct cause and effect can be difficult, identification of risks and their mitigation will always be beneficial. Modifications to the pipework were completed to remove this potential risk. During the Inspectorate's investigation, it was noted that the sample point drainage tundish was a cut off plastic drum and that the sample tap spout was below the lip of the drum (Figure 1). This arrangement presents a risk of contamination with no drainage system and no air gap between the tap and waste should the drum not be emptied. This sampling arrangement is likely to cause a breach of regulation 16 relating to the collection and analysis of samples, and a recommendation was given to improve standards for sample point drainage sinks.

On 9 June 2022 Stockdale Farm service reservoir detected another breach for coliforms, and again, the company did not identify a root cause. Upstream checks at the water treatment works were satisfactory, however a dip sample from Stockdale Farm service reservoir failed for coliforms, and one downstream property also failed for coliforms. The company stated it had plans to modify the pipework at Stockdale Farm reservoir to remove it from supply indefinitely. The Inspectorate concluded that the risk of a breach of regulation 4 for wholesomeness remained and recommended that the company expedites the removal of Stockdale Farm service reservoir from the supply network.

Companies are reminded that where no root cause can be found, the failing asset should meet the required standards in all aspects. Where an asset is not needed (e.g., due to changes in industrial customer demands) action should be taken swiftly to remove the asset from the supply network. Regular appraisal of network systems should be undertaken to ensure efficiency across distribution grids and reduce risks from redundant assets.

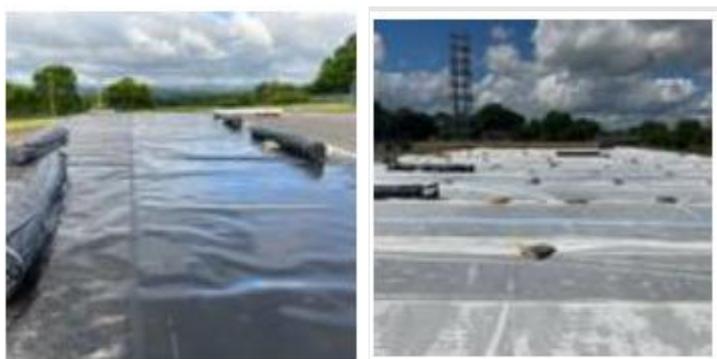
Figure 2: Temporary membrane installed over Whiteborough service reservoirs 8 and 9

Enforcement action is being taken to address overdue inspections at a number of service reservoirs operated by Severn Trent. Among these is Whiteborough service reservoir, where a coliform was detected from the combined outlet of compartments 8 and 9 on 16 May. The company was unable to remove both compartments from supply as this would cause supply issues, however compartment 9 was removed from service three days after the failing sample was taken. The inspection identified ingress around the roof and wall joints. The company installed a temporary membrane over the roof during May and June and started an enhanced sampling regime. The company subsequently had plans to remove compartment 8 from supply.

Whilst these reactive measures addressed the issue, there were delays to putting these measures in place. Both compartments were overdue their 10 yearly inspection and the company had previously inspected and repaired the compartments within weeks of each other in 2012. The sites are critical to maintain supplies and both compartments cannot be removed contemporaneously. All companies are asked to consider, in such circumstances

whether it would be better to stagger the timings of internal inspections and repairs of linked compartments in order to reduce risk of delays. More importantly, companies are advised to ensure that their risk assessments appropriately consider the consequences of a failure and the steps that are required to minimise the risk to consumers, including ensuring the frequency of internal inspection and repair is such that it prevents ingress to service reservoirs.

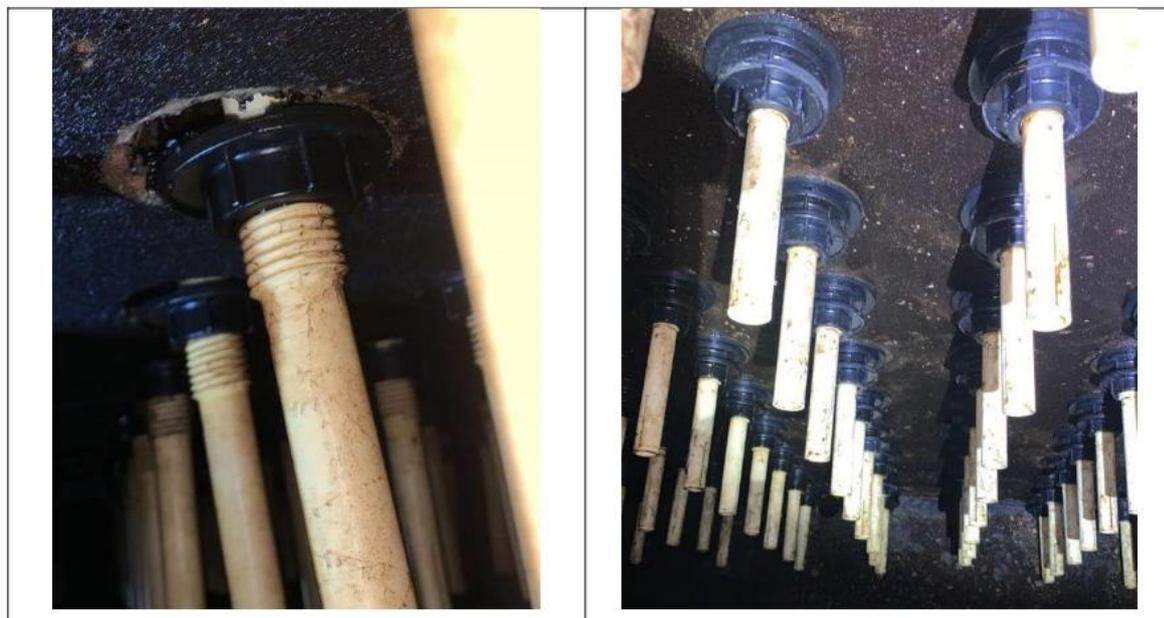
Figure 3 eroding holes and Figure 4 oversized gaskets installed

The work to prevent the filter media carry over was not successful and issues with media carry over continued. This was confirmed during a technical audit of the works by the Inspectorate in November 2021. Southern Water investigations identified the widening of the aperture of the hole which the nozzle sits in the concrete floor as the cause of the issue. Each hole was originally built to be 53mm diameter, however, over time the holes had widened due to the vibrating actions of the backwash and air scour process so that they were approximately 60mm in diameter. Each filter has around 1600 nozzles. Figure 3 shows

the worn holes which were not sealing correctly, leading to issues with carbon loss and bypassing of treatment.

The company is fitting the nozzles with 75mm oversized neoprene gasket washers to ensure a secure fit (Figure 4).

Work to replace the washers was completed on filter numbers 1 and 6, which were returned to service in January and April 2022 respectively.

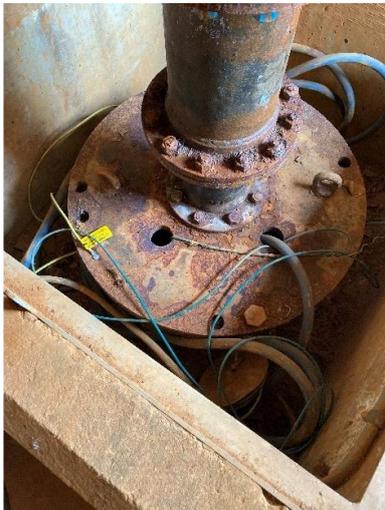
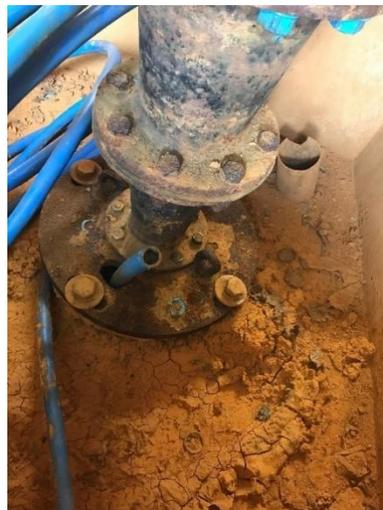
Figures 5 and 6

- At the groundwater sites visited, whilst the general security of the boreholes was satisfactory, a theme emerged with the general condition of the borehole headworks. Un-glanded cable holes and other points of ingress were seen, and at one site the general internal condition of the borehole kiosk was not being maintained. The risks should not need to be spelt concerning inadequate maintenance. Investment in protecting water quality should be a priority.

- At one site, the headworks were below ground level, and there were sump pumps and flood alarms, in case the chamber flooded. A clear identification of a risk with no action. Above ground construction of kiosks is the preferred method of terminating the borehole casing, to reduce risks of surface water ingress if for instance there were to be an un-glanded cable hole. If a borehole is at risk of flooding, consideration should be given to raising the borehole casing to above ground level, with the addition of sanitary sealing to remove the likelihood of it becoming contaminated by surface water (Fig. 5 and 6).

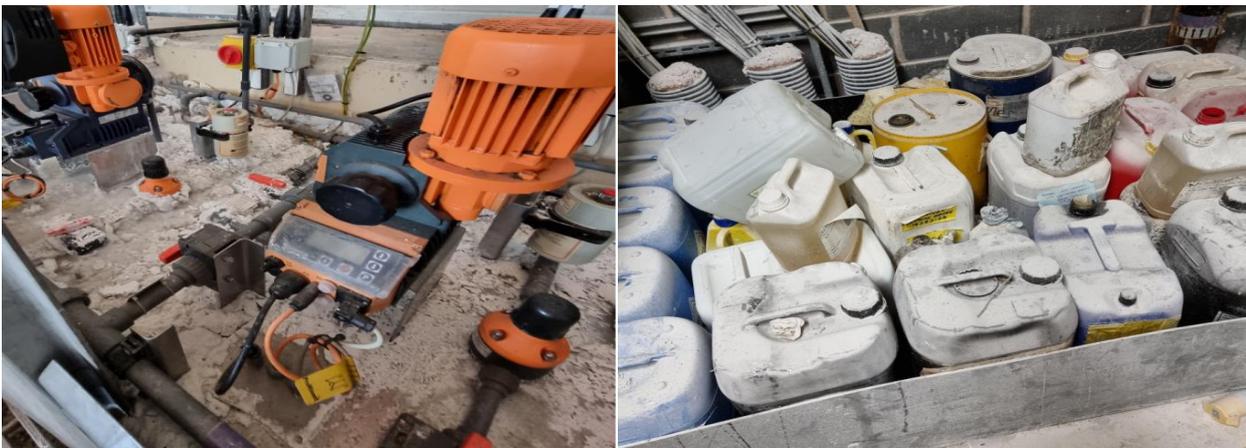
Figures 7 and 8

1. Issues with general housekeeping were also observed, with poor condition of dosing pumps and unsatisfactory storage of chemicals (Fig. 7 and 8). Whilst this does not have an immediate risk to water quality, this questions the care taken in a food production premises where the product is drinking water.

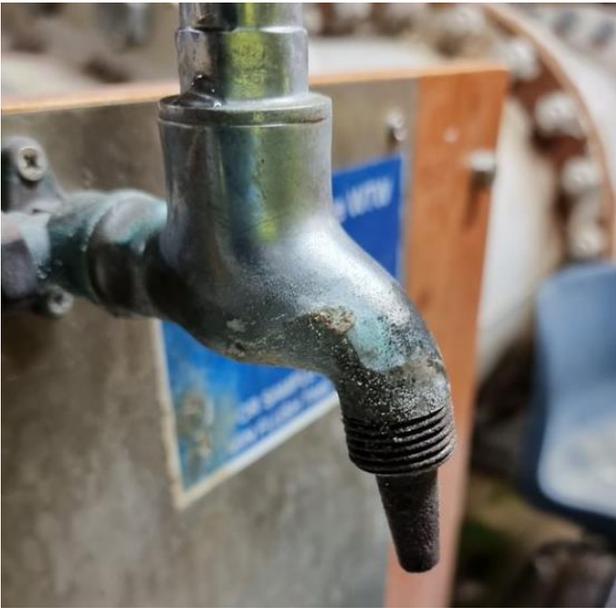
Figure 9

2. The condition of sample taps was also noted to be of a poor standard at several of the sites visited. One sample tap was leaking. Water companies should ensure that sample taps are maintained and replaced as necessary to remove the risk of an unrepresentative sample being taken and equally sets an example of reducing waste. Suitable sampling facilities reduce the risk of failure, with associated investigations and penalties (Fig. 9).

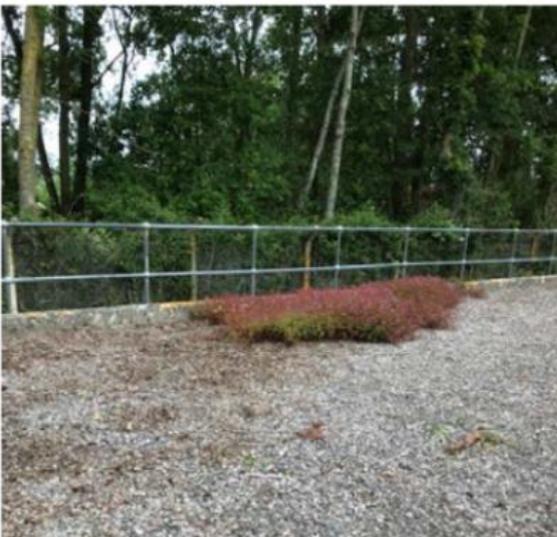
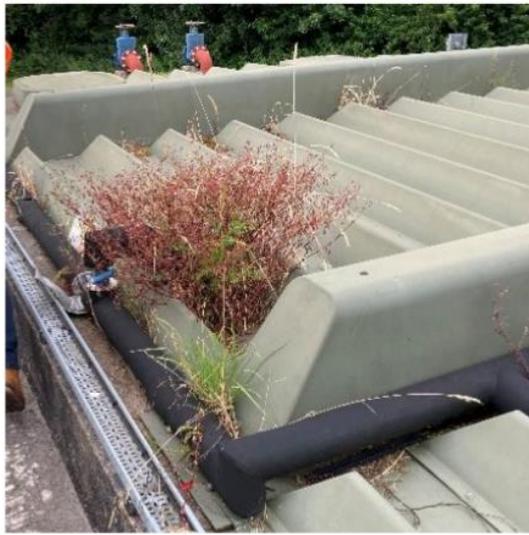
Figures 10 and 11

- Issues with grounds maintenance were identified, including the growth of shrubs and weeds near built structures, and in one case, on the roof of a treated water tank (Fig. 10 and 11). Companies should ensure that structures are kept clear of weeds and other vegetation to prevent root growth compromising the integrity of the structures.

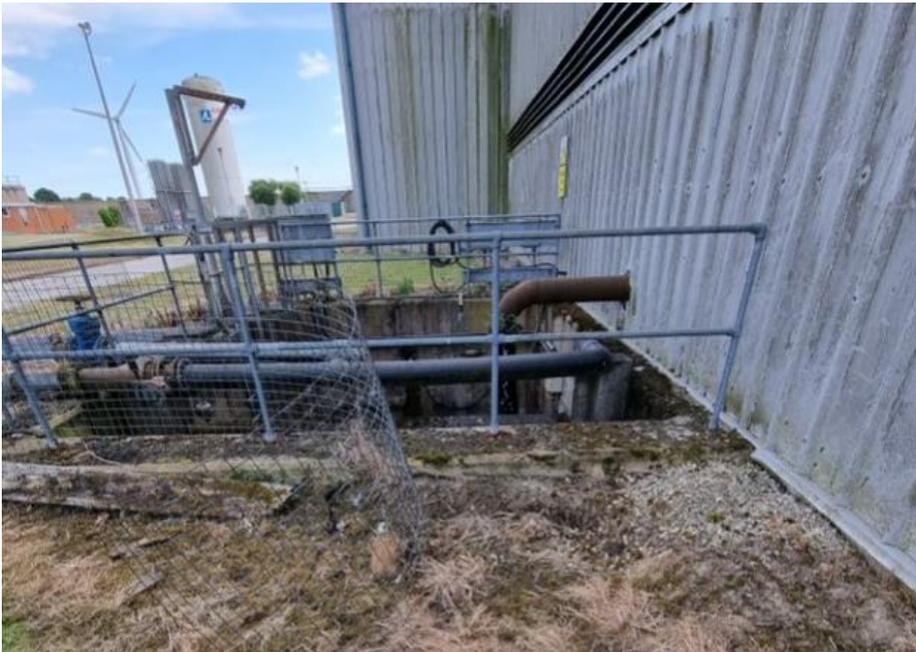
Figure 12

- At one site, a vermin control fence protecting a wash water recovery tank was damaged and had not been repaired (Fig. 12).
- One company was unable to locate an overflow pipe from a treated water tank. Companies were reminded of the importance of understanding where all outflow pipework is located. Outflow pipework should be included on regular inspections to ensure that physical measures such as flap valves and meshes are in place to prevent animal or insect entry.
