### **Case study 7 – An outbreak of *Escherichia coli* O157 infection amongst users of a private water supply when staying in holiday accommodation**

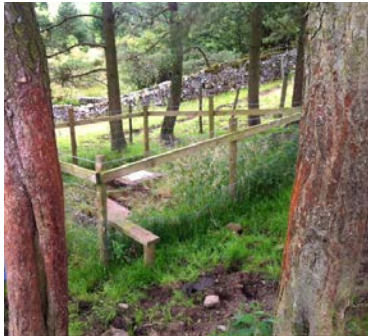
**Figure 12: Situation of the source**

The private supply spring source is located in a wooded area of grazing pasture on hillside above the premises (see Figure 12).

As part of the outbreak investigation the local authority applied the Inspectorate's risk assessment tool and consulted with the Environment Agency. This revealed that the underlying bedrock in the spring location is fissured limestone. The general area has some drift cover of clay but this was absent in the immediate vicinity of the spring. These natural features make the source vulnerable to fast surface water in-flows creating a direct route for surface contaminants to enter the spring source. It was also found that a significant change had occurred in the catchment. A new tenant farmer had commenced grazing of the pasture by cattle, not sheep. During times of inclement weather, including heavy rainfall in late July, the cattle had taken to sheltering in the woodland where the spring was located. The cattle had damaged the fencing and had been defecating in the immediate proximity of the source. Historic maintenance of the supply had not included inspection and cleaning out of the spring water holding tank and the tank was not fitted with either an inlet or outlet sediment trap.

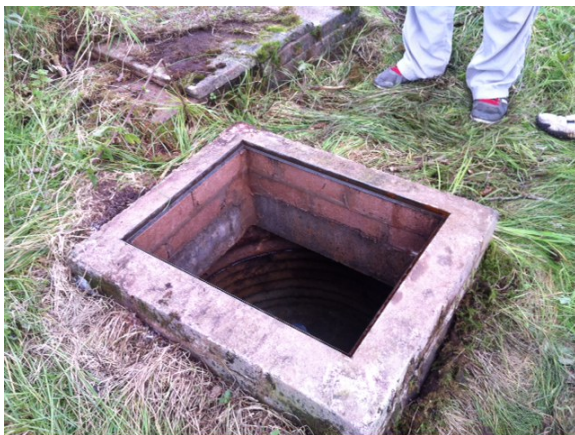
**Figure 13: Holding tank**

Water is piped from the source holding tank to five storage tanks located at one of the three premises situated adjacent to one another in a valley with land abutting a small river. The water is then piped into the treatment room where it goes into another pre-treatment holding tank, before passing through a pre-filter and a UV disinfection unit.

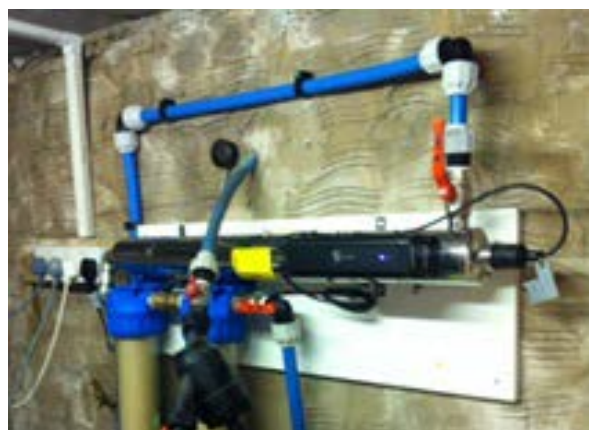
**Figure 16: UV treatment**

Immediately following the putting in place of the first restriction Notice, the owner of the supply who lived in one of the three premises called in the maintenance engineer. The engineer's visit revealed that the disinfection system was operating but it was undersized. The equipment was designed to treat a flow of 9 litre/min whereas demand from the three premises when fully occupied was of the order of 45 litre/min. The Inspectorate's risk assessment tool guides local authorities to consider, where treatment is already in place, whether it is adequate to treat the current volume of water which is being used – i.e. at normal and peak flow periods. The engineer identified the need for a larger disinfection unit sized to treat 60 litre/min. In addition, the pre-treatment in place was a filter of nominal 250 micron size. Such a filter acts only as a coarse screen to remove larger particles, not to achieve the required 1NTU prior to disinfection. To adequately pre-treat water for UV disinfection of spring water the pre-treatment should include a second finer filter of five micron or less and this should be preceded by a 20 micron filter. Coarse screens should be located at the source tank. These issues were addressed immediately by the installation of new equipment which consisted of a 60 litre/min UV unit preceded by two cartridge filters, the first being five micron and the second being one micron nominal pore size.

The equipment was also fitted with a 'fail safe auto cut off' device to prevent forward flow of water that may not have been disinfected in the event of a power failure. Following these works the pipe network was chlorinated and flushed through. A six monthly maintenance contract was set up with the water treatment engineer and a comprehensive water safety plan was put in place.
