PRIVATE WATER SUPPLIES – CASE STUDY 2018/01

Rainwater harvesting private water supply

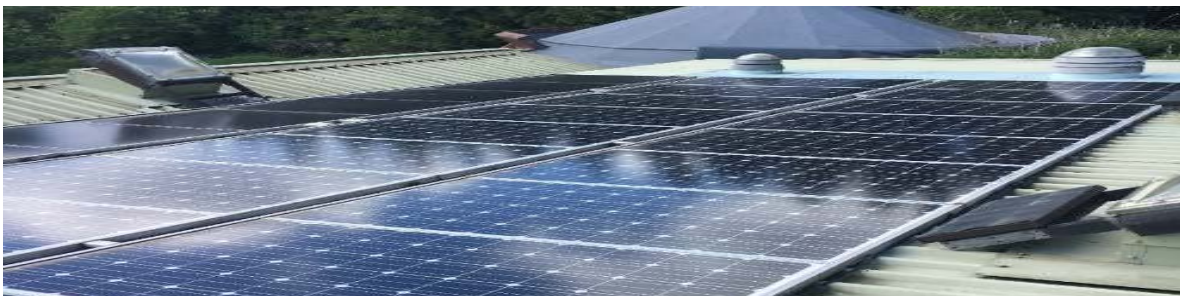
A subsequent site visit to carry out a Regulation 6 risk assessment identified that solar panels had been installed on the eco-centre roof from where the rainwater is harvested. Antimony is a common component of solar panels and is therefore a potential source of the antimony detected in this supply. However, the local authority did not further investigate the cause to narrow down the likely source of the contaminant. Local Authorities are encouraged to carry out comprehensive investigations as required under Regulation 16 (18 in Wales), which should include sampling at the various stages from source to tap in the supply system. This can help determine where a contaminant may be entering the system, so that suitable mitigation measures can be considered and implemented.

Figure 17: Solar panels installed on the roof which is used for rainwater collection.
