PRIVATE WATER SUPPLIES – CASE STUDY 2014/02

Classification of tourist springs and wholesomeness issues

Historic springs that are used as a tourist attraction

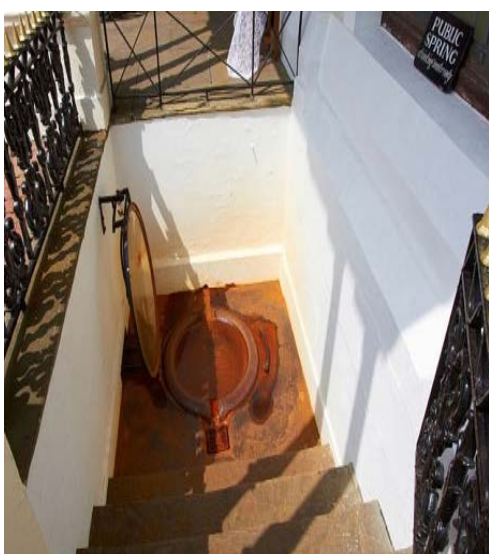
Figure 16: Public spring

The case study involves a historic drinking water fountain where, during the tourist season, water is served to the public for a fee by people dressed in costume known as 'dippers'. In this way public access to the spring water is controlled and minimised to a 'tasting' experience. (see Figure 16) The spring is not used for domestic purposes at the tourist attraction, there being a separate public supply available for other public facilities.

In 2010, work in the neighbourhood to repair a gas main led to the rupture of a sewer with consequential contamination of the ground. Fortunately the 'dippers' were alerted to the fact that something might be wrong with the spring water by a strong odour. When the well water was tested it was found to contain very high numbers of *E.coli*. The spring was closed to the public and not reopened until after the pollution event was remedied and water quality returned to normal. More recently, the flow to the spring stopped.

While the cause has not been fully made clear, it is probably linked to construction works to create an underground walkway at a nearby hotel. These works required large quantities of groundwater to be continuously pumped out from the excavation to enable the walkway to be built and for the concrete to set. The long-term fate of the spring in terms of both sufficiency and quality will only be determined after the completion of a

The risk assessment of this supply was carried out in November 2013. Routes of ingress by vermin and surface water existed due to the piping arrangements and because the feature was open to the elements. In addition to these microbiological risks, the water exhibited a range of other natural characteristics making it unwholesome: iron ($>30,000\mu\text{g/l}$), manganese ($>2,000\mu\text{g/l}$), turbidity (78NTU), pH (5.8), taste (metallic) and odour (sulphurous). To mitigate the microbiological risks by disinfection would have required the turbidity associated with the iron and manganese to be reduced substantively so that disinfection was effective. However, in this scenario the usual reasons for requiring removal of iron and manganese, and pH correction to meet these national standards were not applicable. For example, the water did not need to be clean to ensure that it was not rejected for personal hygiene due to its appearance. Likewise impaired functioning of toilet flushing, laundry and central heating would not arise. The microbiological risk could therefore be mitigated in a practical way by making improvements to the source to prevent ingress and making sure that public access was restricted to just supervised tasting sessions.

The Regulations should not be seen or used as a barrier to the continued use of these historic water features in the future for the benefit of the tourists and the local economy. The regulatory priority should be to carry out a risk assessment and where the supply is not wholesome and safe for all domestic purposes, consider how the public access to the supply can be limited and controlled so as to maintain the tourism benefit. Usually this will mean that steps need to be taken to ensure that any public facilities (toilets, cafes, accommodation) are served by a mains supply and the public are actively discouraged from filling their own containers with water from the historic supply. As part of the risk assessment process, the local authority should ensure that the local planning authorities, utility providers, landowners and the Environment Agency are made aware of the historic feature and take into account the need to safeguard this water resource in terms of decisions they make.
