PRIVATE WATER SUPPLIES – CASE STUDY 2014/11

Illegal connection

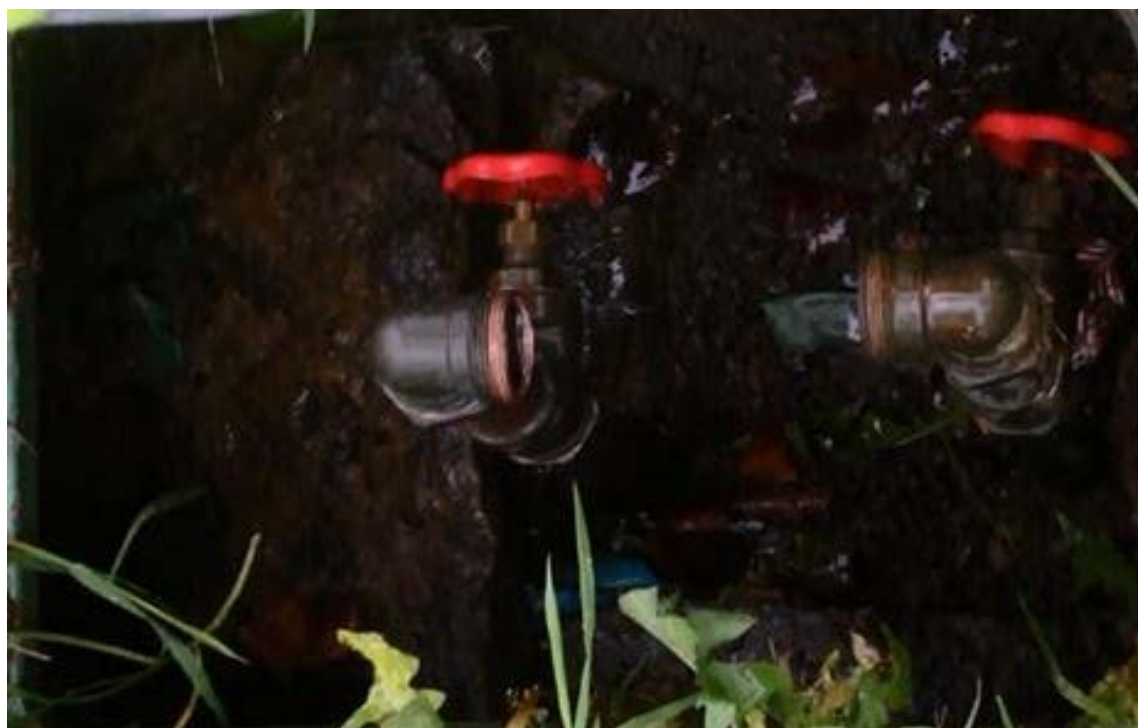
The company promptly investigated in order to establish whether the meter was running backwards due to a fault or whether there was an illegal cross connection between the mains water supply and the private borehole. Chlorine readings indicated that there may have been a cross connection with the private, untreated borehole supply. The Water Regulations Inspector identified an illegal cross connection and removed it. Figure 20 shows the pipework following removal of the cross connection.

It was noted that following removal of the cross connection, the valves were leaking even when shut off, so even with the pipe in place and valves shut the mains supply would have remained unprotected as there was still a risk of untreated water entering the mains distribution system through this connection.

Figure 20: Pipework after illegal cross connection had been removed

Prior to the cross connection being removed, the private borehole was found to be delivering a pressure of 4.5 bar and the water from the private supply could potentially have reached the pumping station supplying the mains water in addition to the properties supplied from the pumping station. In reality, due to pressure being maintained by the pumping station, it was thought that the farm and a neighbouring farm were the only ones affected. Historic water quality data for the borehole was generally good, and a microbiological sample taken as part of the investigation was satisfactory. However, phosphate results at a neighbouring farm were lower than would have been expected for an exclusively mains fed supply and bottled water was supplied as a precaution until flushing had been undertaken and satisfactory sample results reported.

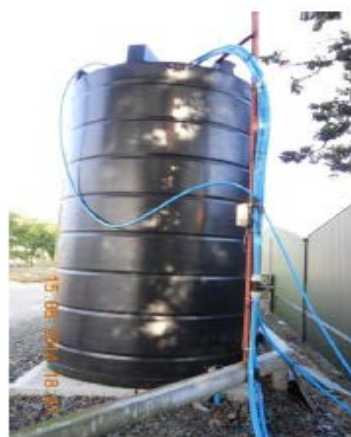
The farm manager described the supply arrangements; the mains supply feeds the house and the dairy. The borehole water is not hydraulically linked to either of these premises. The untreated borehole water feeds into a large black plastic tank to supply the farm (Figure 21) – this has a connection to the mains supply for a top up if required. These arrangements mean that borehole water is only used for domestic purposes at the farm, therefore the supply constitutes a single domestic dwelling and as such the owner had not requested a risk assessment or monitoring.

Figure 21: Tanks in which mains water and borehole water were blended and stored

A water fittings inspection revealed that the mains connection into the storage tanks for the farm had no air gap as required and therefore the borehole water could backflow into the public water supply through the meter as observed by the meter reader. The water from the boreholes has very similar water quality to the water in the public supply. Initial sampling surveys were therefore inconclusive as to whether borehole water was circulating in the wider public distribution network. Microbiological results showed that the water supply at the farm itself and one downstream property contained coliforms, and the downstream property also contained Enterococci. Further samples over the following two days were microbiologically satisfactory.

The company served a water fittings Notice requiring several improvements, including the creation of an air gap between the private and public supplies where they mix in the tanks. They also replaced the meter with one with an inbuilt non-return valve. In this case the water company were not aware of the private water supply on site and therefore the potential for cross-connection or backsiphonage.
