PRIVATE WATER SUPPLIES – CASE STUDY 2013/06

Case of *E.coli* 0157 associated with a private supply to a rented property

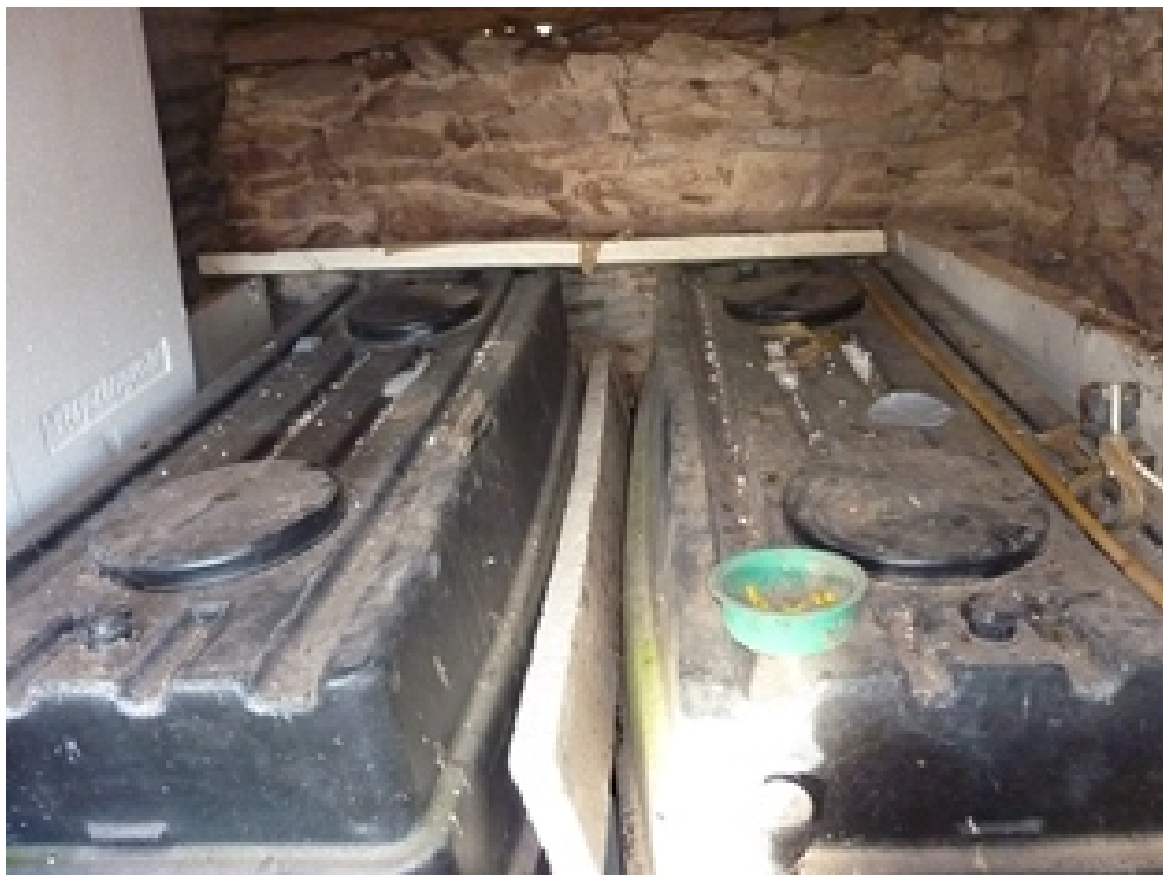
The source of the water supply was a well sunk into a minor aquifer, deemed vulnerable to pollution by the EA due to the nature of the overlying soil and flow characteristics of the aquifer itself. However, the well was located in a field used for grazing cattle. The wellhead works were raised above ground level and protected with a suitable inspection cover. Water from the well is fed into two black plastic tanks located inside a secure outbuilding.

Figure 15: Black plastic storage tanks

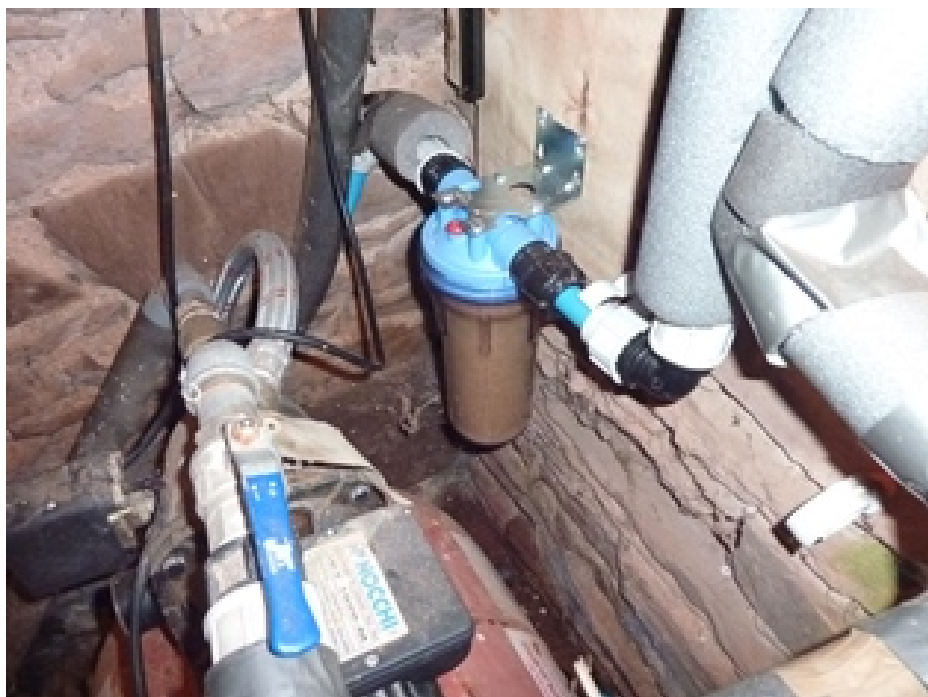
Figure 16: New 5 micron cartridge filter prior to UV disinfection

When the local authority and PHE visited the site in response to the tenant contracting an *E.coli* 0157 infection, it was evident that the stock proof fencing had only just been erected. Additionally, it was found that the UV disinfection system lacked a pre-filter and the water exhibited a turbidity value of 8.5NTU (compared to the standard of 1NTU for water prior to disinfection). *E.coli* 0157 was detected in a sample of the raw water together with other faecal indicators. The local authority formalised advice to boil water in a Regulation 18 Notice and required the water supply system to be cleaned and disinfected, and a filter to be installed before the UV unit.
