## PRIVATE WATER SUPPLIES – CASE STUDY 2013/12

### Deciding whether a situation comprises a public or a private water supply

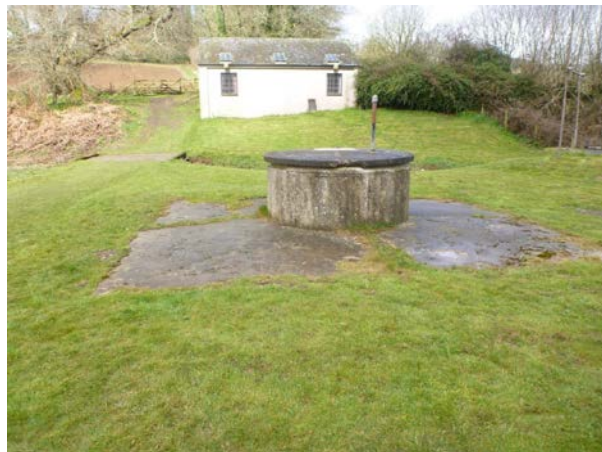
**Figure 18: Old Well Headworks in foreground and pump house in background.**

A river runs through the estate and in the 1960s the then local *water board* sank a well on the opposite side of the river bank to the estate's *old well*. The *water board well* was of a specific shallow horizontal type known as a radial collector (Ranney), designed for installation in shallow sub-surfaces to collect water as it infiltrates from a riverbed. At the time of its construction, it was alleged that the Ranney would compromise the yield from the *old well* on the opposite bank, due to its depth and close proximity. In response, the water board made a verbal agreement with the trust to augment the *old well* supply at no cost to the trust and constructed a raw water main to enable a transfer of water directly from the Ranney to the *old well*.

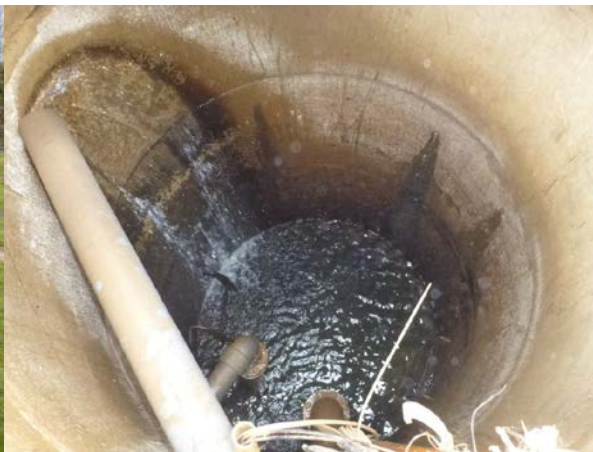
**Figure 19: Old Well interior showing iron-ductile pipework rising main, incoming raw water supply from South West Water**
