Drinking water 2018
Public water supplies for
England and Wales

Quarter 3
July – September 2018

Published by
Drinking Water Inspectorate
Nobel House
17 Smith Square
London
SW1P 3JR

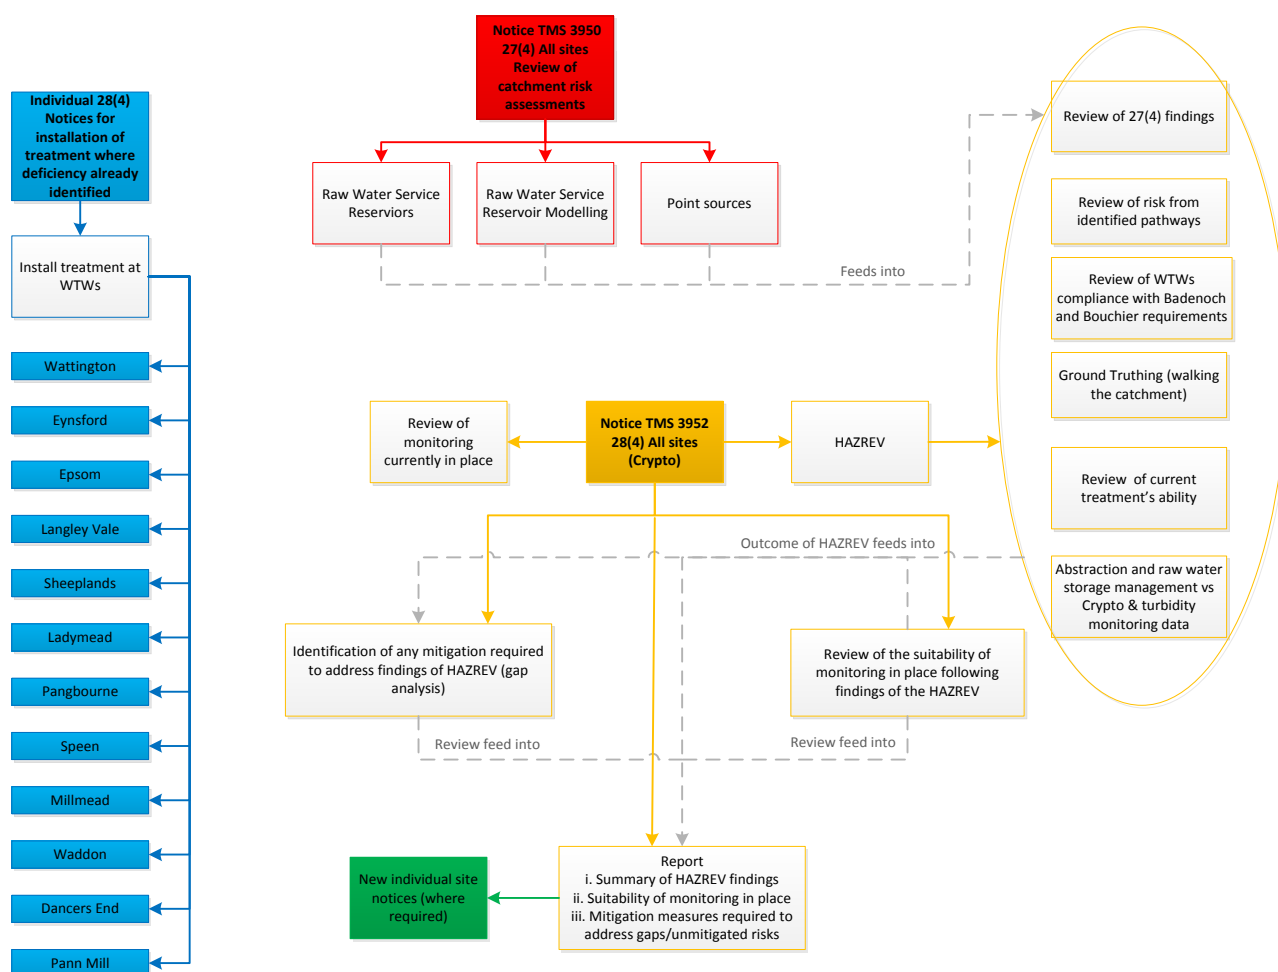
Figure 8: Overview of the *Cryptosporidium* work stream of the Thames Water transformation programme.

The 14 Notices served this quarter related to *Cryptosporidium*. This included a Regulation 27(4) Notice, and 13 Regulation 28(4) Notices, one for all sites and 12 for installation of treatment at individual sites (see Figure 8).

The Regulation 27(4) Notice was served for the review of the company's *Cryptosporidium* catchment risk assessments at all sites following the identification of deficiencies. The risk assessment review includes; a review of the contamination risk from raw water storage reservoir; raw water storage modelling assessment; and a review of the risk posed by *Cryptosporidium* point sources around abstraction points and within

The *Cryptosporidium*, 'all sites' Regulation 28(4) Notice includes (among other things) an in-depth hazard review (Hazrev) to identify all aspects that could constitute a risk to water quality and public health from *Cryptosporidium*. The Hazrev includes specific elements (see Figure 8) to address gaps that were identified with the company's control of the risk from *Cryptosporidium* within their catchments, raw storage management and at their water treatment works.
