PRIVATE WATER SUPPLIES – CASE STUDY 2012/2

Contamination event due to insufficient source protection

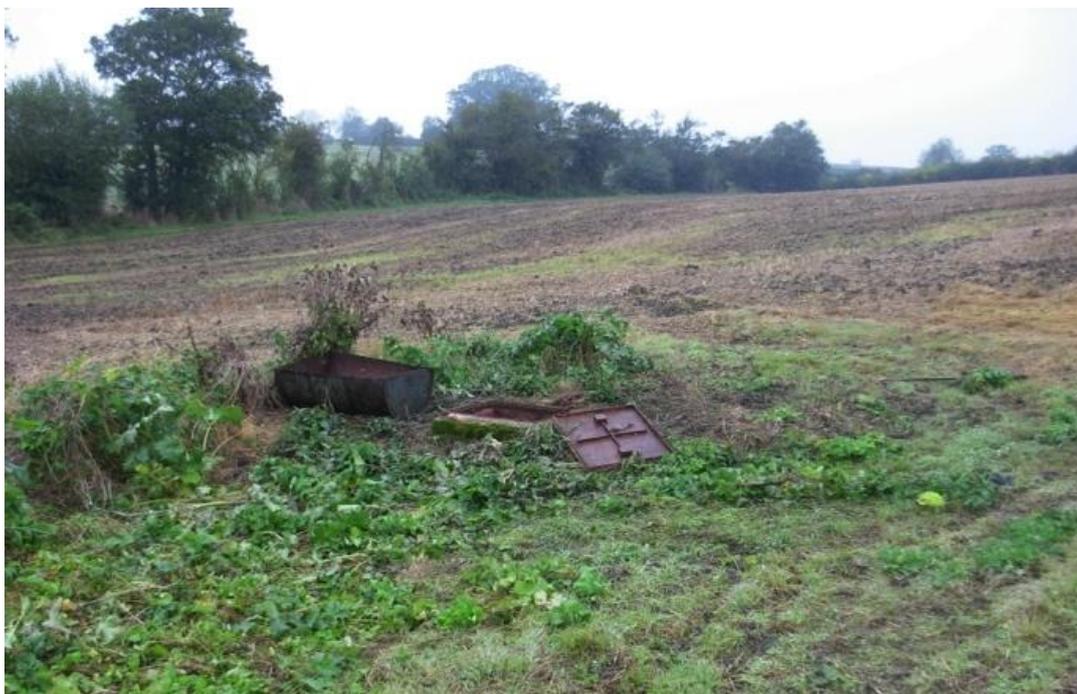
Figure 10: Location of spring chamber in field

In October, the farmer who owns the field hired contractors to spread bio-solids (sludge cake) on his farm. When the contractor arrived to undertake the task, he misunderstood his instructions and applied sludge cake to the field where the spring was located. At the time the spring was obscured by long grass. Next day, the farmer was contacted by two users of the supply who both reported an unusual odour in their tap water. In response, the farmer advised all of the users not to drink the water. He arranged for the spring to run to waste and for the connection to the public supply to be opened. He also notified the local environmental health officer who attended the site later the same day. The 'do not drink' advice was formalised in a Regulation 18 Notice, samples were taken and the water company was informed.

The root cause of this water quality event was a human error, which revealed that the source protection arrangements were not sufficiently robust to safeguard the supply. This case study provides practical evidence of the benefits of relatively simple safeguarding measures such as fencing off sources located in fields. If the local authority had formalised the findings of the risk assessment in the form of a written action plan with requirements for appropriate and timely validation by the owner, this event may have been prevented. *The Inspectorate has noted that some local authorities are still placing too much reliance on sample results as the primary basis of their decision making, whereas, as this case study shows, satisfactory sample results do nothing to safeguard a supply from hazards that are left unmitigated.*
